CALIFORNIA PUBLIC UTILITIES COMMISSION
Safety and Enforcement Division
Electric Safety and Reliability Branch

Incident Investigation Report

Incident Number: E 20191030-05

Location of the Incident: 200 Block of West Los Angeles Avenue
Simi Valley, CA
County: Ventura

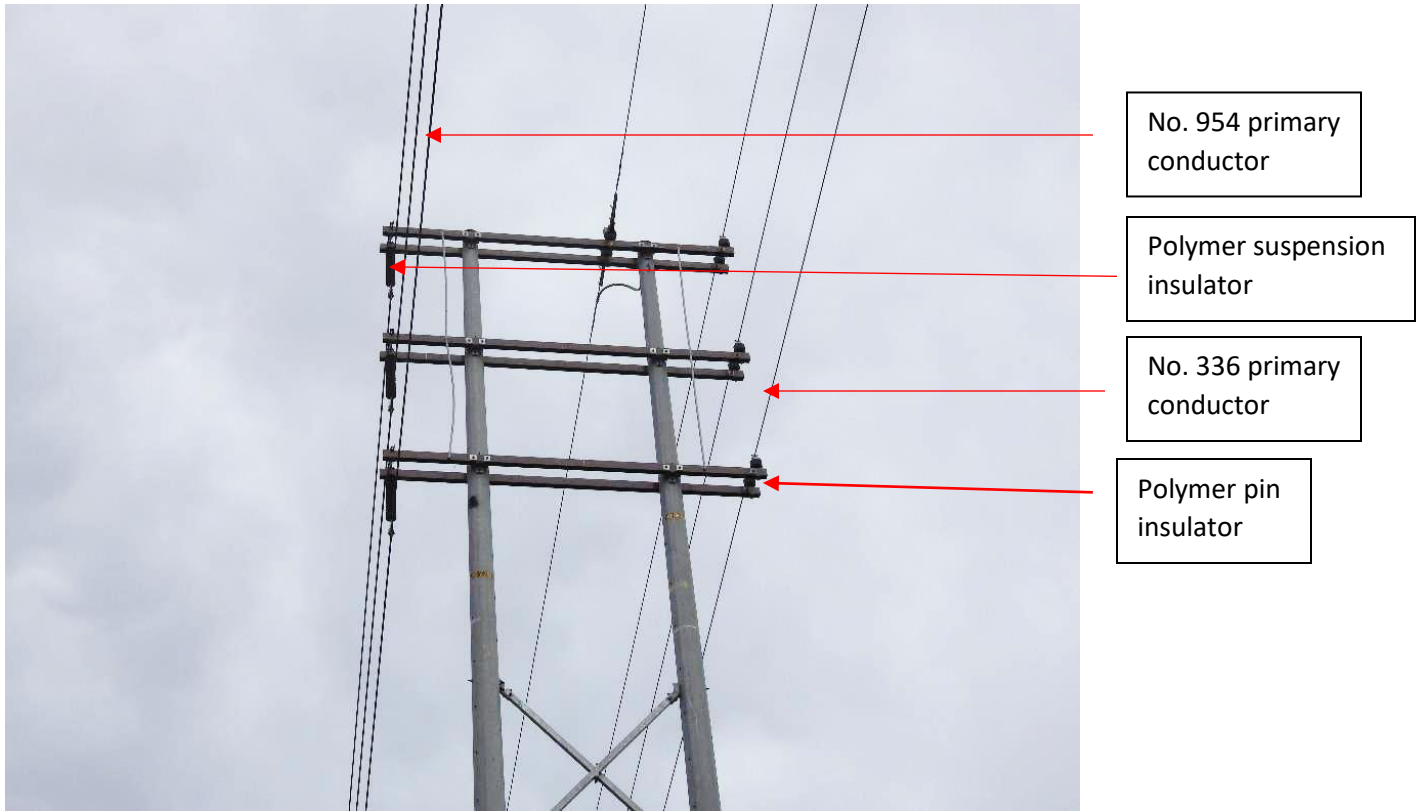
Figure A: SCE poles numbered 4244905 E and 4244906 E

SCE poles numbered 4244905 E and 4244906 E, as shown in Figure A, were 100-foot-long lightweight tubular steel poles creating an H-frame. These poles supported 3 sets of double dead end 20-foot composite crossarms. The north side of the crossarms contained 3 polymer suspension insulators that supported no. 954 Aluminum Conductor Steel Reinforced (ACSR) primary conductors. The south side of the crossarms contained 8 polymer pin insulators that supported no. 336 ACSR primary conductors. Additionally, this H-Frame contained 2 bond wires and a fault return conductor.

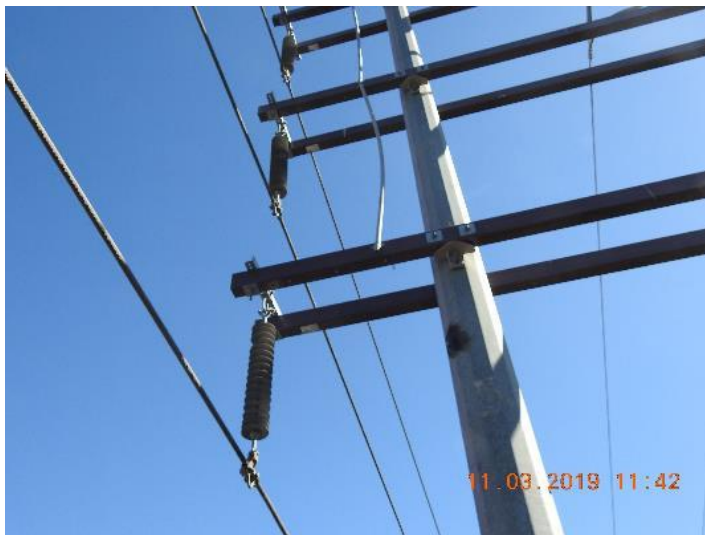
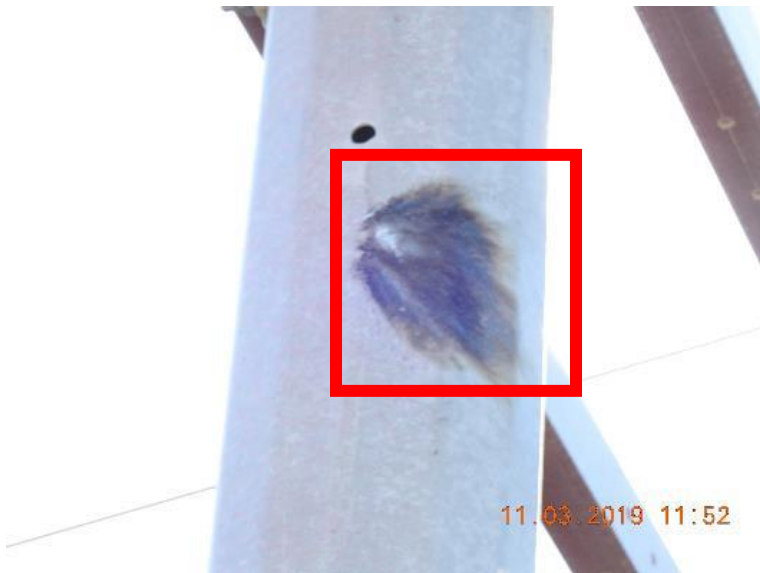
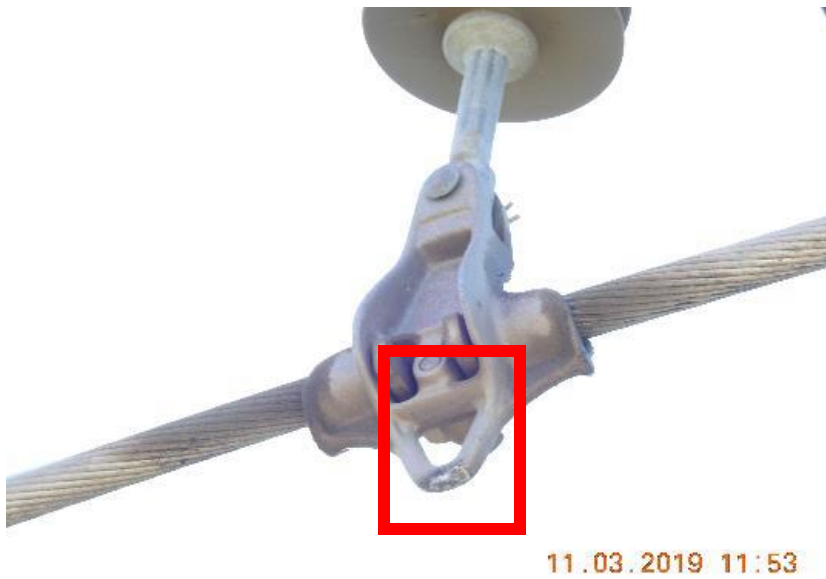
While on the site of the incident, I observed a black burning mark on pole number 4244905 E, and discoloration and deformation on the lowest suspension insulator (Figure 1). Both the pole and the suspension insulator were in proximity of the origin of the fire and the observed damage appeared to be the result of an arc between the insulator's clamp (where the conductor is attached) and the steel pole.

Figure 1: The damaged insulator, burning mark on the pole and cables (marked red)

In a letter dated February 3, 2020, SCE stated that the LIDAR survey showed the horizontal clearance between the lowest portion of the clamp (that is attached to the bottom of the insulator) and the pole was 3.68 feet.

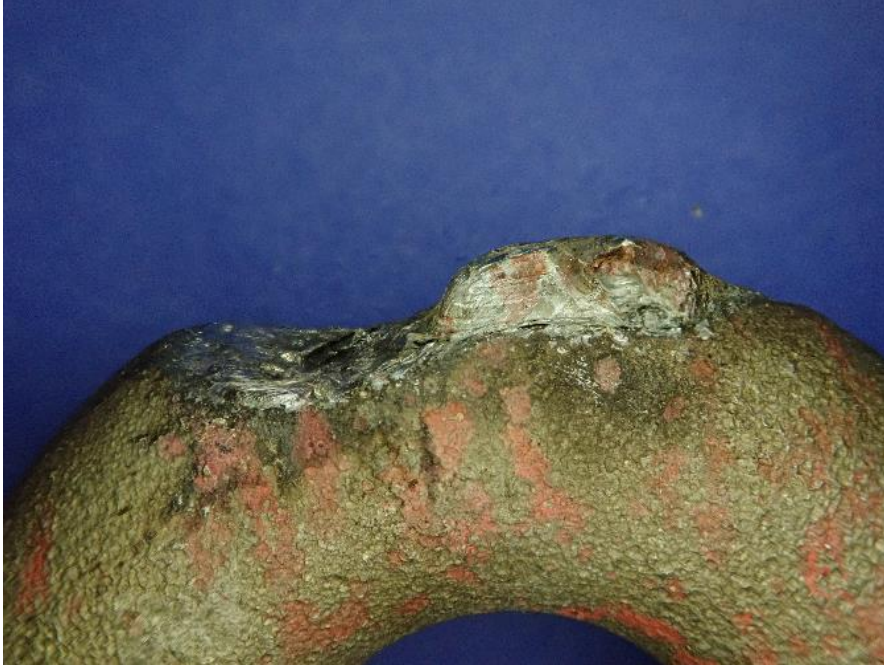
Figure 2: The damaged insulator shoe (suspension clamp) ¹
