CALIFORNIA PUBLIC UTILITIES COMMISSION

Incident Investigation Report

Incident Number: G20210127-3173

Utility: Pacific Gas and Electric Company (PG&E)

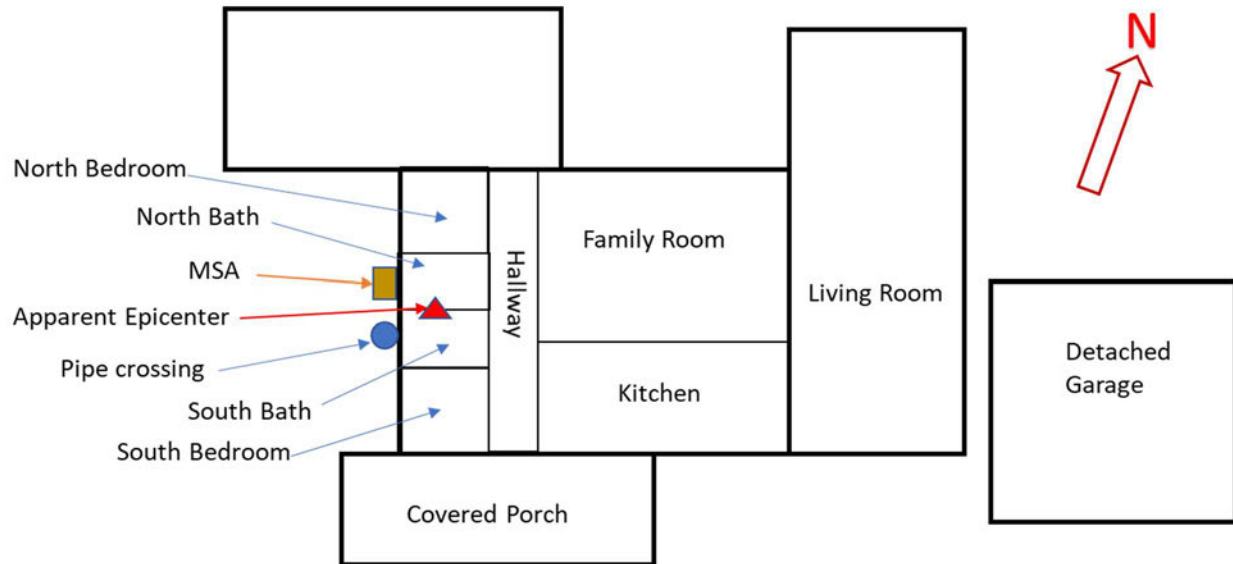
Figure 1: Floorplan (not to scale) of █████ Lakeview. The yellow box represents the gas meter set assembly. The red triangle represents the apparent epicenter of the explosion. The blue circle represents the area where the 3/4-inch gas service line and the sewer drain cross.

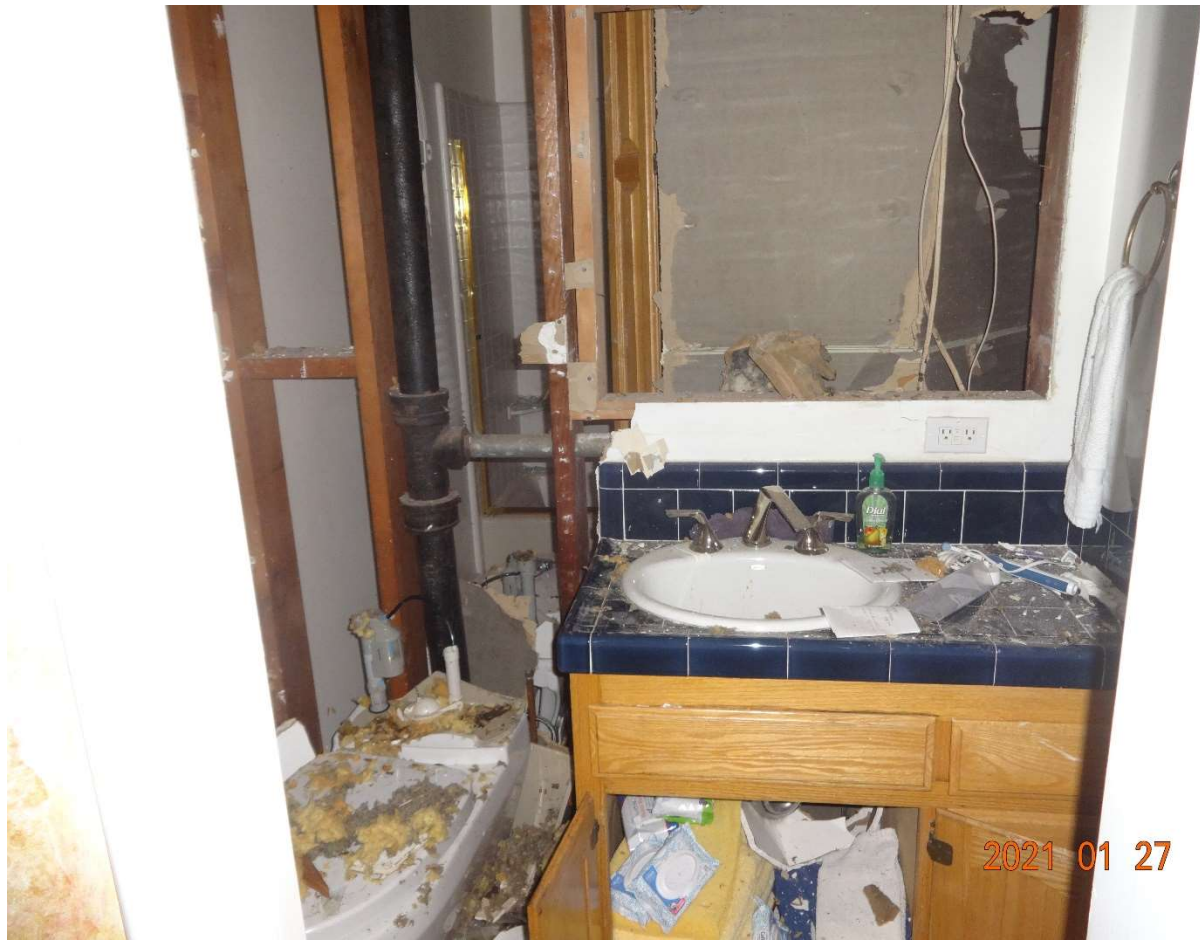
SED was allowed inside the house to inspect the damage. The apparent epicenter of the explosion was the wall between adjacent bathrooms. The sheetrock had separated from the studs, insulation had blown out of the wall cavity, and the sewer drainpipe was visible. The walls in both the North and South bathrooms exhibited significant damage (Figures 2 and 3). There was minimal damage to the rest of the home. [REDACTED] [REDACTED]

Figure 2: The damage to the South bathroom. The sheetrock and insulation had blown out from the wall. The toilet tank was shattered.

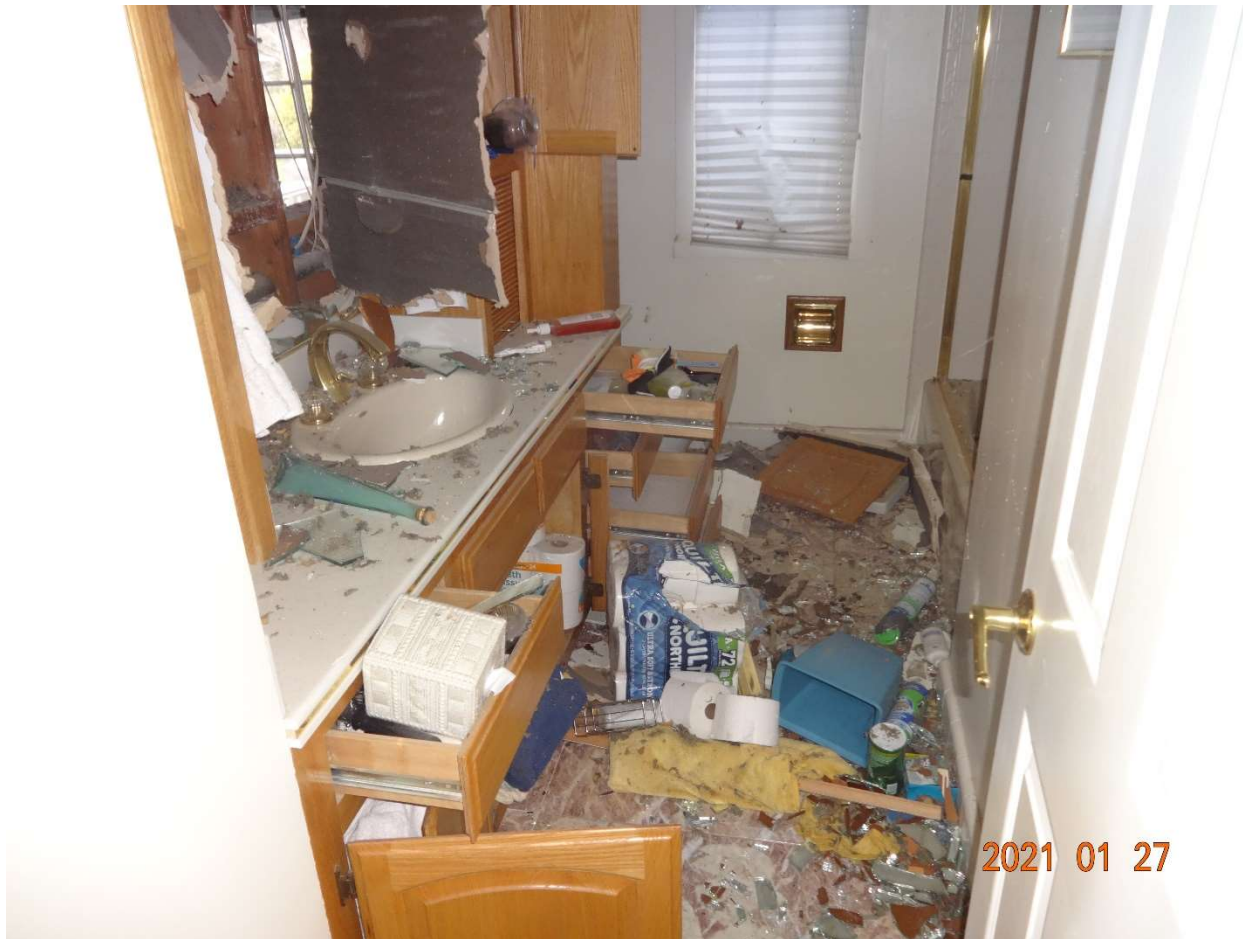
Figure 3: The damage to the North bathroom. The sheetrock and insulation had blown out from the wall. The wall mirror and the sliding glass doors around the tub were shattered.

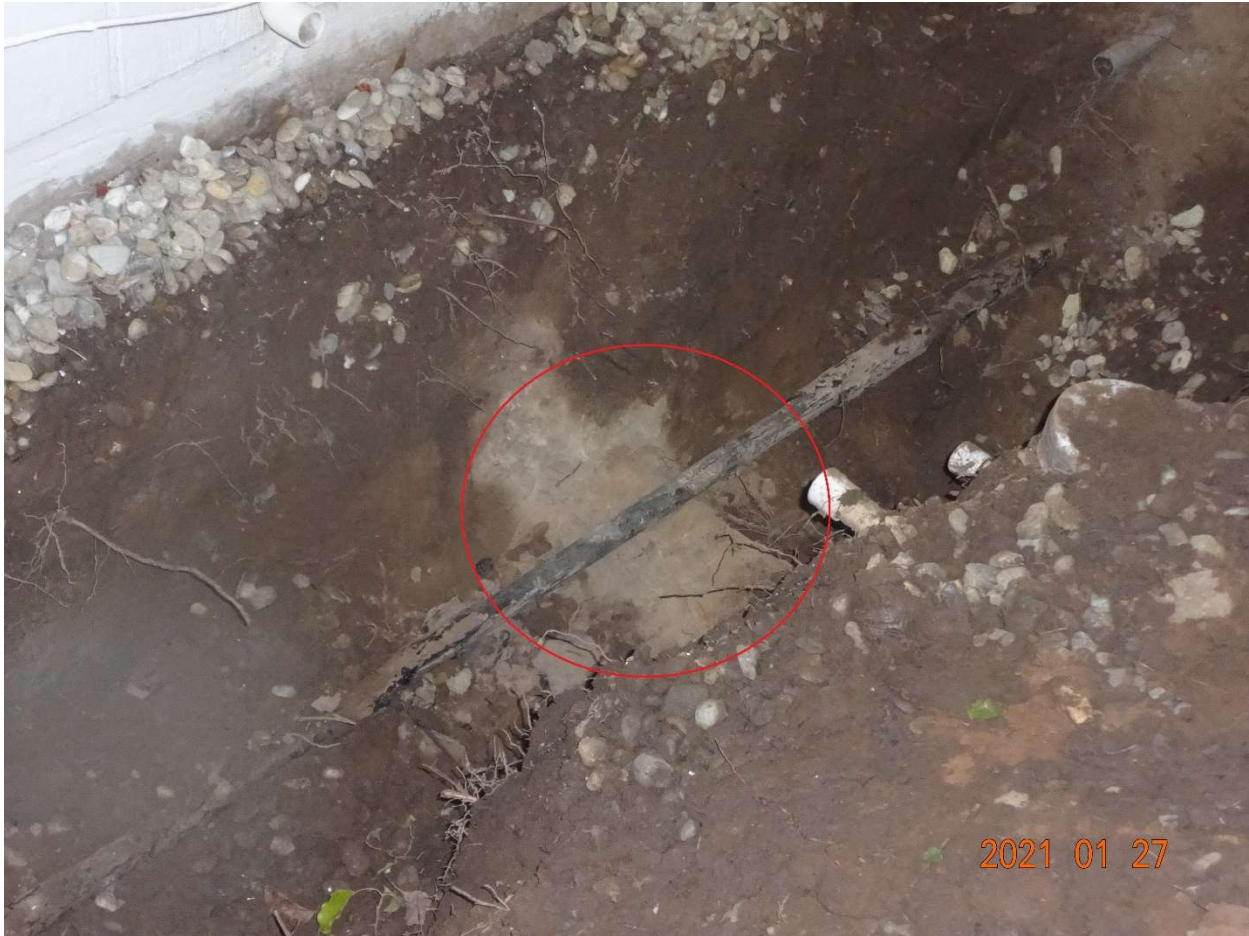
After inspecting the inside of the home, SED went out and observed the area where the meter service assembly had been. PG&E had removed the meter and excavated the service line adjacent to the house. The excavated area and the dirt which was removed was pungent with odorant. The gas line was approximately 12" below grade. There was a sewer drain lateral pipe in the excavated trench in contact with the 3/4-inch gas service. The sewer lateral ran under and parallel to the gas service line (Figure 4). The dirt in the area around the sewer lateral was dried out, although the rest of the dirt in the trench was moist. During a conversation with the Field Service Supervisors on site, SED learned that a portion of the dirt that was removed from the trench was also dried out. This dried section of soil is indicative of an underground natural gas leak.

Figure 4: Excavated trench next to the house with 3/4-inch gas service line and sewer lateral. The red circle highlights where the two pipes are in contact. The soil near the intersection of the pipes was dry, although most of the soil brought up from the pit was wet.

PG&E proceeded to leak test the isolated section of service line with compressed air, from the curb valve to the service riser termination. The air test revealed a leak on the underside of the service line where the gas service line was in contact with the sewer lateral. The section was cut out and retained by Exponent, a third-party forensic engineering contractor.

On February 25, 2021, Exponent performed materials testing on the service line at their lab. SED was able to view the testing remotely. Exponent reported that they found a hole on the service line, approximately 3/8 inches in diameter, at the six o'clock position. The hole was located approximately 4 feet from the riser, where the gas service line had been in contact with the sewer lateral. The section near the hole was devoid of pipe coating, but Exponent was unsure if that had been removed during the excavation or if it had been missing coating before that.

PG&E states in their Root Cause Evaluation report that Exponent found “the damage to the incident pipe was consistent with an electrical arc event between the service line and the sewer lateral.” According to the report, “Sacramento Municipal Utility District (SMUD) experienced a wire down event of a 12.47kV overhead electric primary distribution circuit due to a storm. This downed line was located approximately 300 feet northeast of the incident leak location.” SED observed the clean-up from that downed line event on January 27, 2021. Although the precise current path is not known, it is possible that the downed electric wire contacted and energized the secondary neutral, which would have allowed current to flow onto the ground wiring of the homes and the sewer pipes.
