**PUBLIC UTILITIES COMMISSION**

**SUBJECT: Generation Audit of Desert Sunlight – Audit Number GA2023-12DS**

## I. Findings Requiring Corrective Action

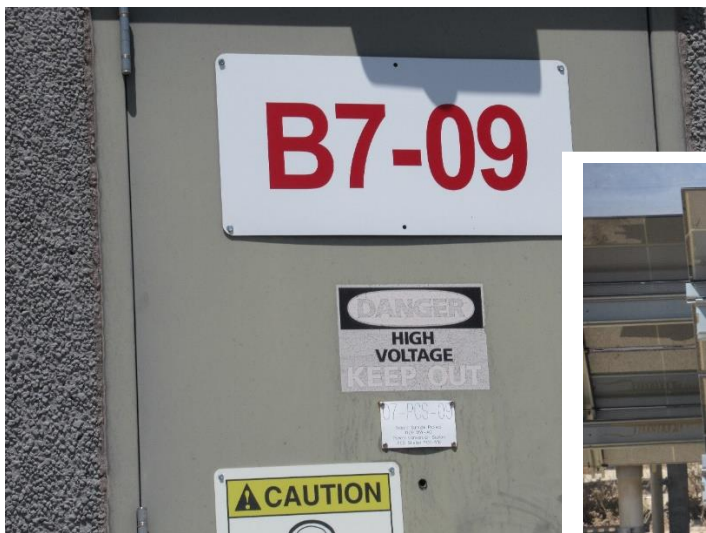
ESRB staff observed faded High Voltage signs on the inverter facilities. ESRB staff also observed faded Arc Flash stickers and identification stickers on the combiner boxes. These ID signs are important for the quick identification of equipment, and they help hasten repairs or maintenance being completed. The safety signs help inform employees, contractors, and visitors who may be unfamiliar with the equipment and its inherent dangers. All eligible signs must be replaced to display pertinent hazard information complying with NFPA-70 E and relevant OSHA regulations.

Figure 1: Faded High Voltage Sign on inverter facility door.

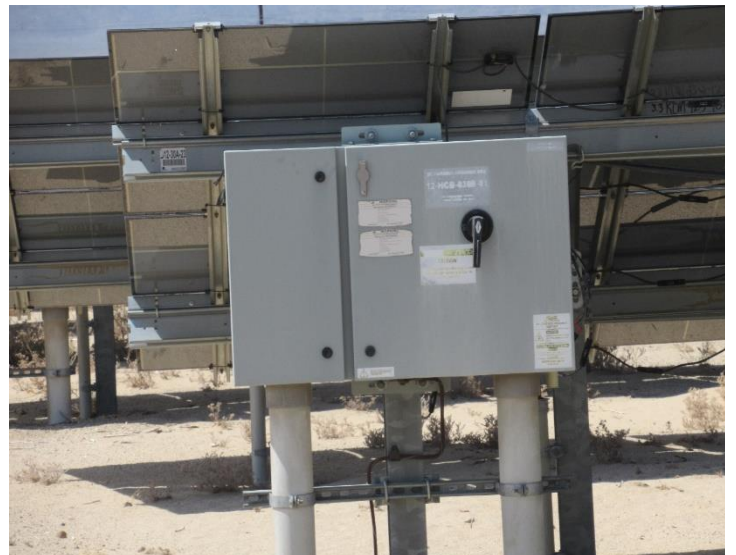
Figure 2: Faded signs/labels on the combiner boxes

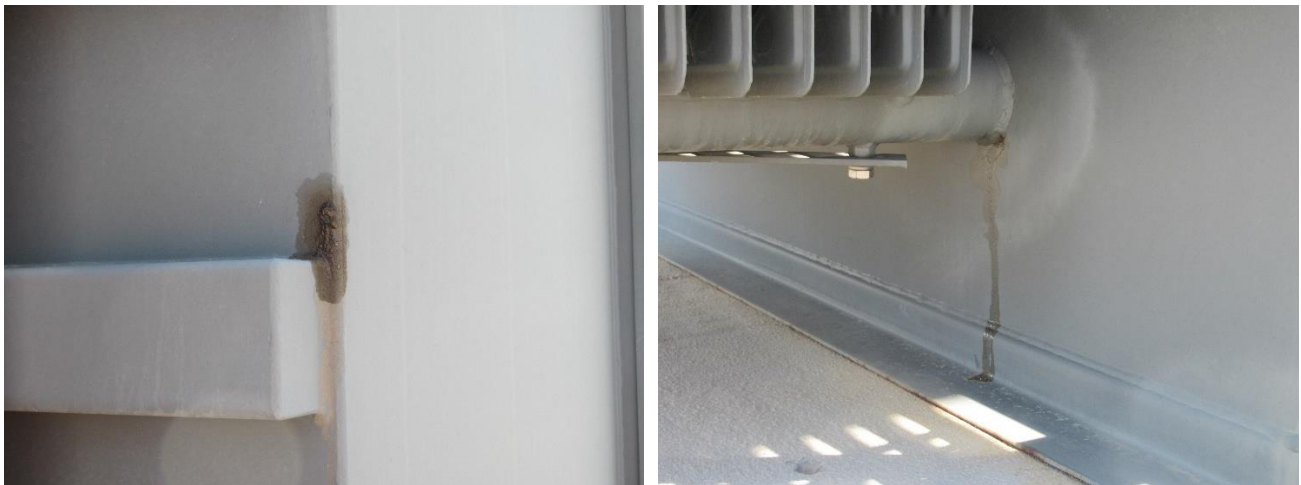
ESRB staff observed oil leaks on the transformers next to Inverter B8-09 and B18-06. Staff also observed oil leaks in the substation from GSU1 at the radiator valve and flange, as well as GSU2 near the bottom of the transformer and from the LTC drain valve. The plant must investigate the leakage to identify causes and evaluate any possible operational and structural anomaly of equipment for corrective actions ensuring safety and reliability of the critical assets and personnel.

Figure 3 & 4: Pinhole Oil Leaks from Transformers next to Inverter B8-09 and B18-06.

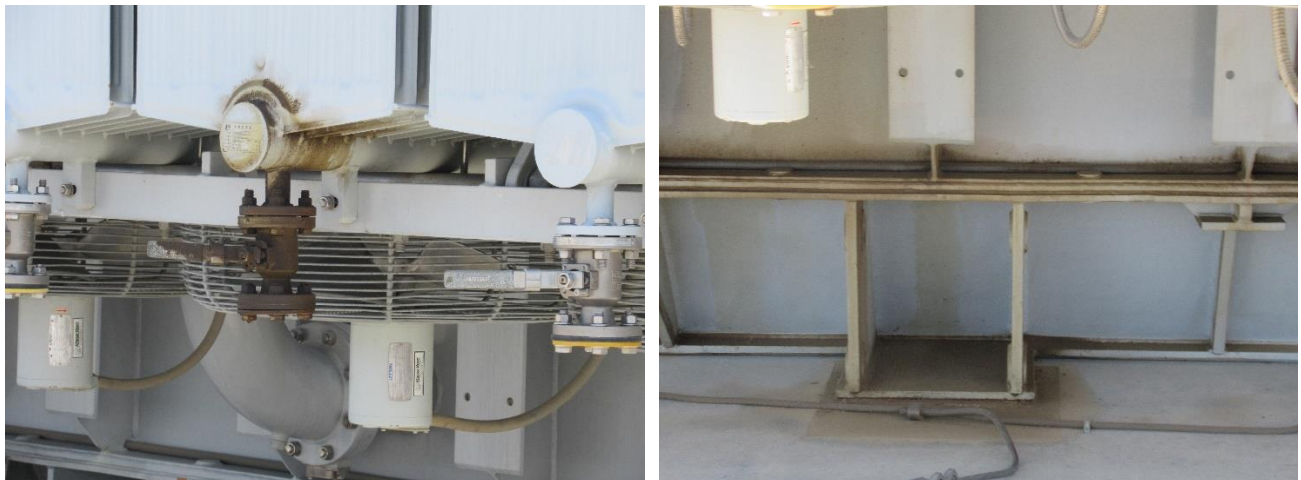
Figure 5 & 6: Oils Leaks on Transformer GSU1 in substation.

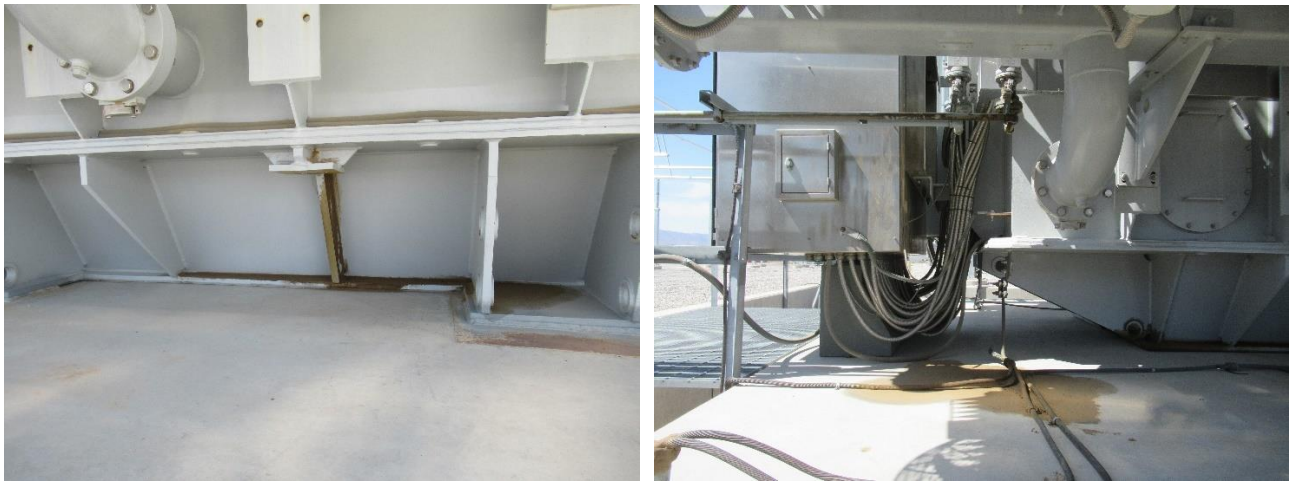
Figure 7 & 8: Oils Leaks on Transformer GSU2 in substation.

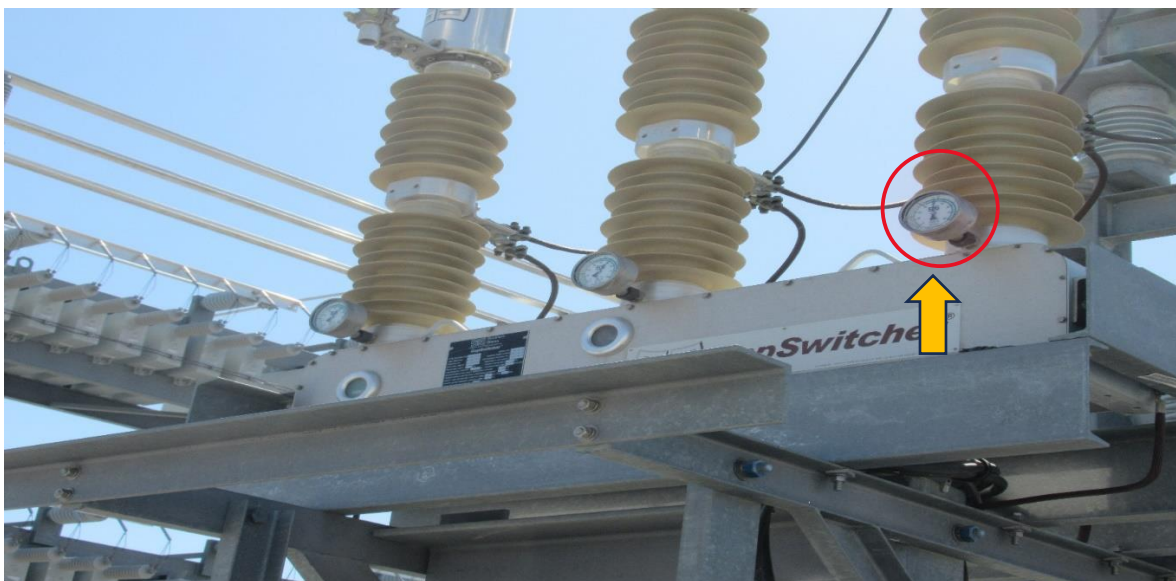
ESRB staff observed that the C phase SF6 pressure gauge for DSSC22 capacitor bank breaker had a lower level compared to the other phases. This lower level may indicate an SF6 leak from the C phase breaker and/or a faulty pressure gauge. The plant must investigate and take actions to ensure the integrity of the breakers.

Figure 9: SF6 Pressure Gauges for DSSC22 Capacitor Bank.

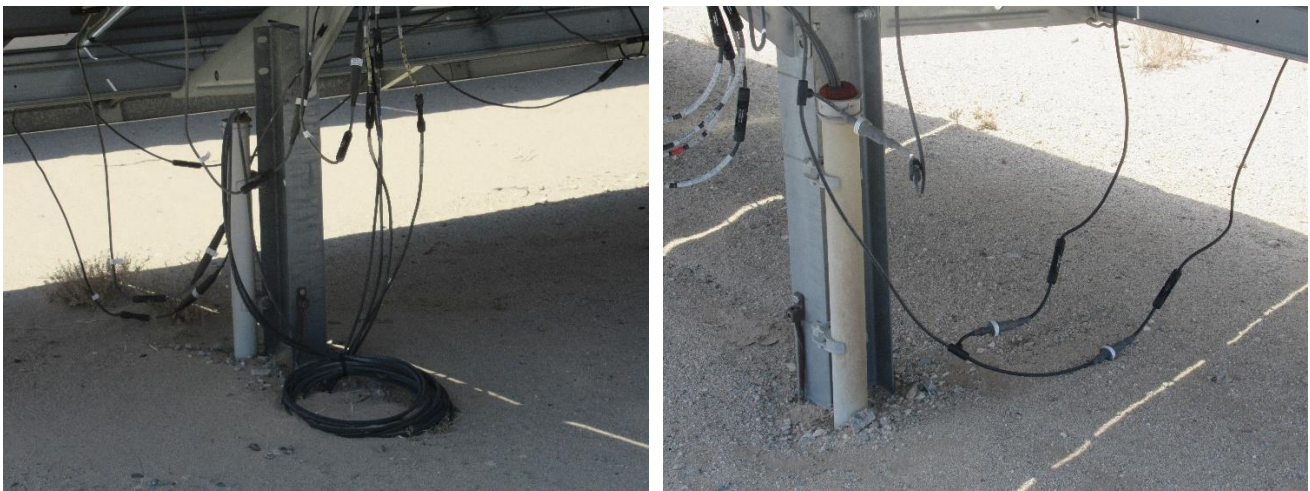
ESRB staff observed multiple solar panels with loose cables touching the ground, particularly in Block 1 and Block 3 arrays. The unsecured cables and straps are susceptible to be damaged and can result in other hazards. The Plant must ensure all the cables are properly secured.

Figure 10 & 11: Loose cables touching the ground in Blocks 1 and 3 arrays.

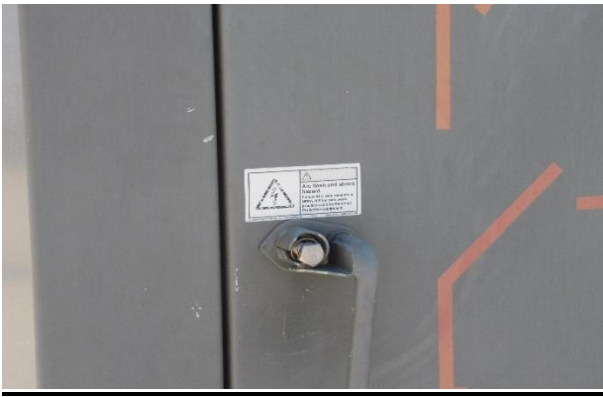
Figure 12: 07- PVCS Switch Cabinet

ESRB staff observed that the cabinet doors for the pad-mounted electric switches 07-PVCS and 18-PVCS were not properly secured. The doors did not have locks on them and while they did have Penta bolts, the Penta bolts were not properly screwed into the door. Unsecured doors may allow unauthorized personnel access to equipment. All high voltage cabinets of the plant must be inspected and properly secured.

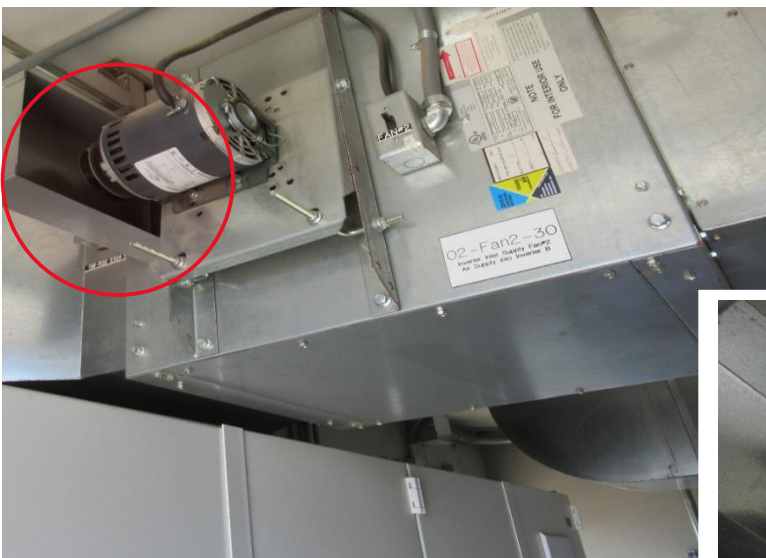
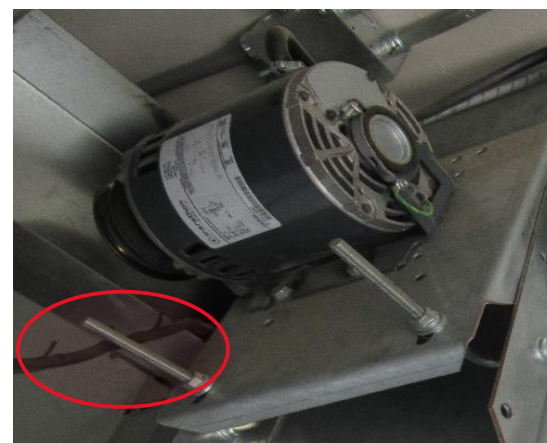
ESRB staff observed that the belts for the inlet supply fans in Inverter B2-30 were broken or missing. The cooling systems are critical components for the inverters which expose to extreme heat condition surrounding the plant especially in hot summer season. The failed cooling system indicates a lack of maintenance activities for the vital and heat sensitive equipment. The plant management must establish routine inspection programs and verify the completion of maintenance activities to ensure intended functionality of the equipment.

Figure 14: Damaged Belt on Inverter Cooling Fan

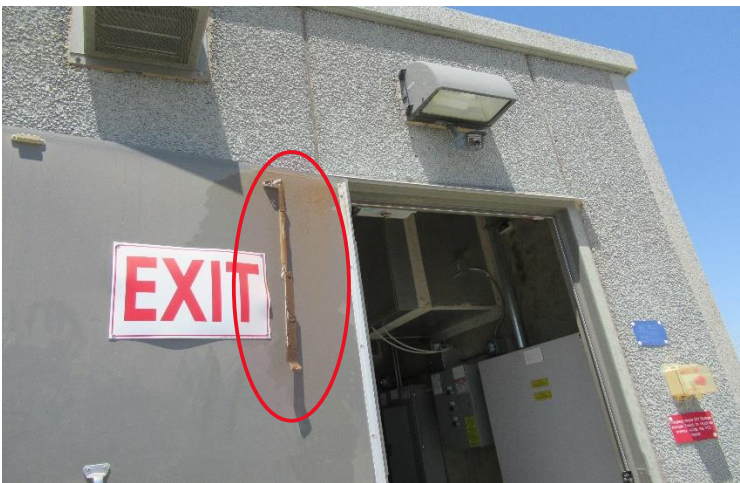
Figure 15: Inverter B10 02.  
The door auto closing mechanism was broken. This may have inverters exposed to dust, vermin and rainwater and result in the system failure and damage.

ESRB staff observed several damaged items around the plant. The plant management must establish comprehensive inspection programs to identify damage, malfunction on the balance of plant and verify execution of routine maintenance activities to eliminate unnoticed latent problems and equipment failure.

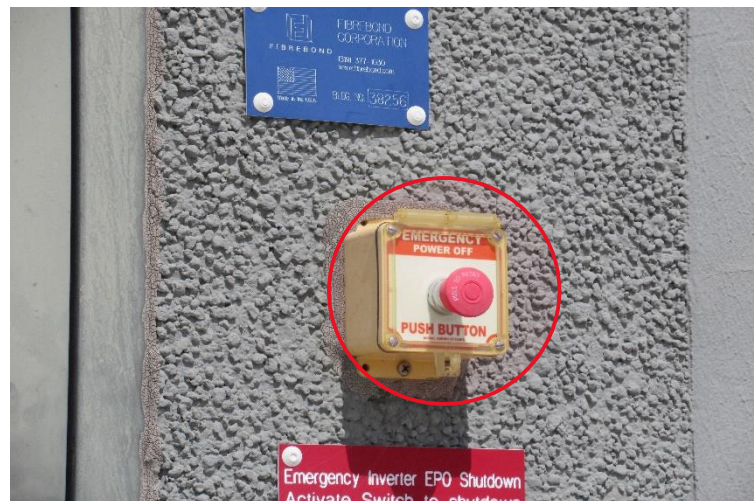
Figure 16: Inverter B12 07.  
Emergency Shut-off Button cover was missing. This may cause inadvertent system shutdown and damage.

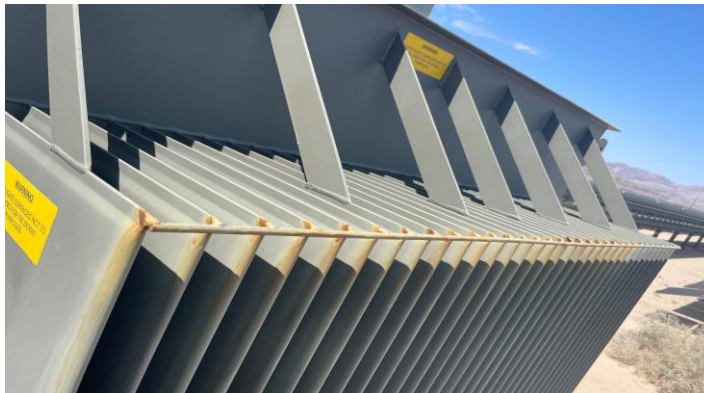
ESRB observed atmospheric corrosion on multiple pad-mounted transformers specifically on radiators and their oil pipes. Plant-wide inspection and examination are recommended to identify corroded transformers and develop action plans to prevent further progress on the high voltage critical equipment.

Figure 18: Rust on Inverter B12-07 Transformer.
