CALIFORNIA PUBLIC UTILITIES COMMISSION
Safety and Enforcement Division
Wildfire Safety and Enforcement Branch

Incident Investigation Report

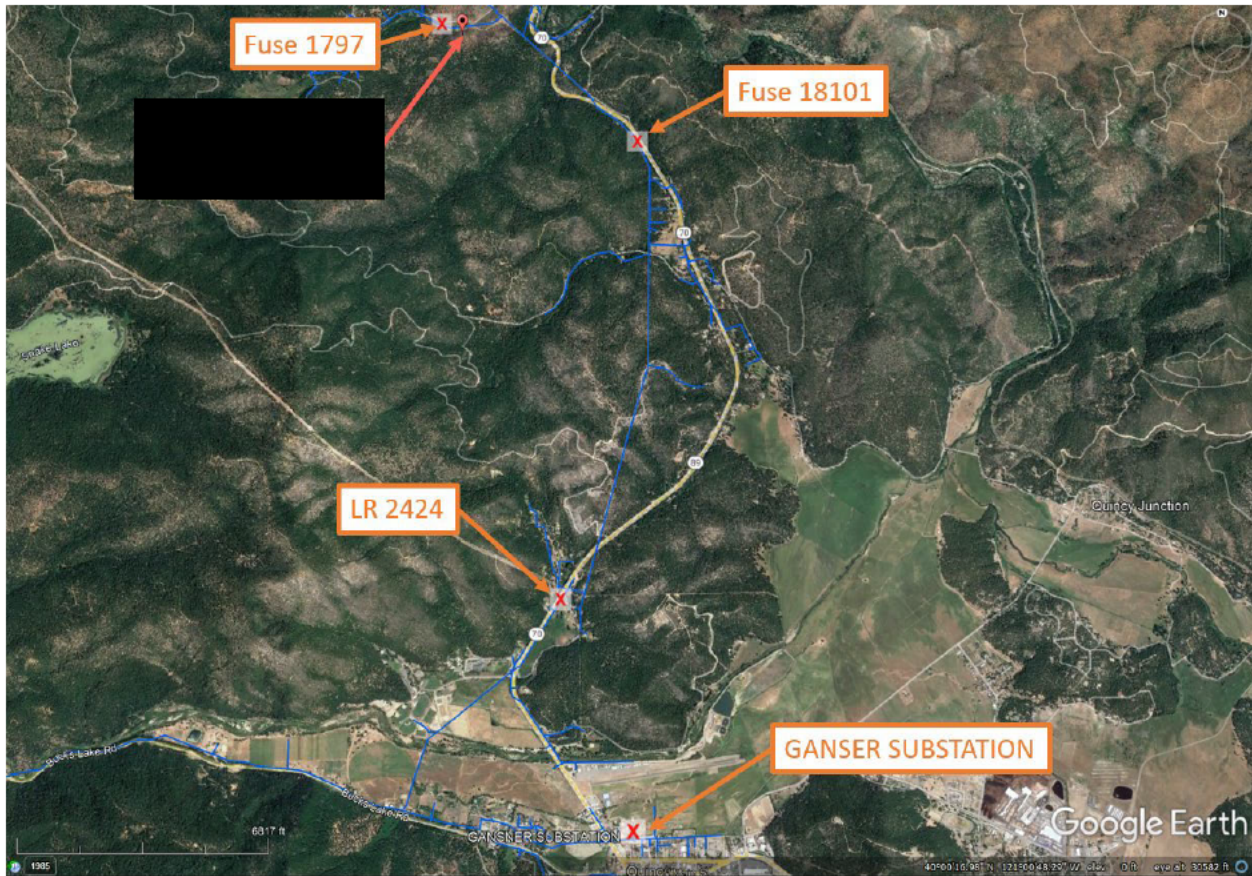
Figure 2: Map of Subject Circuit and Relevant Protection Devices¹⁸

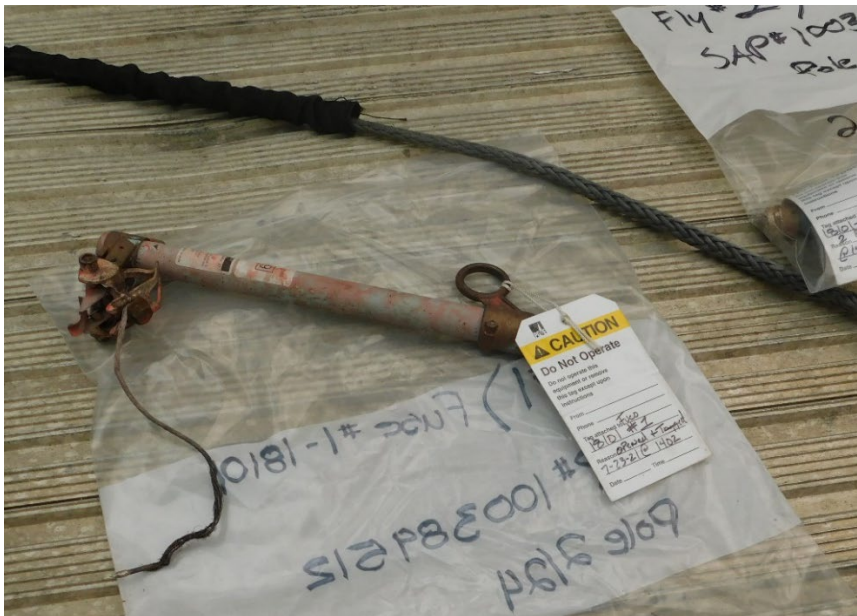
Figure 3: Blown fuse upstream from Incident Area.

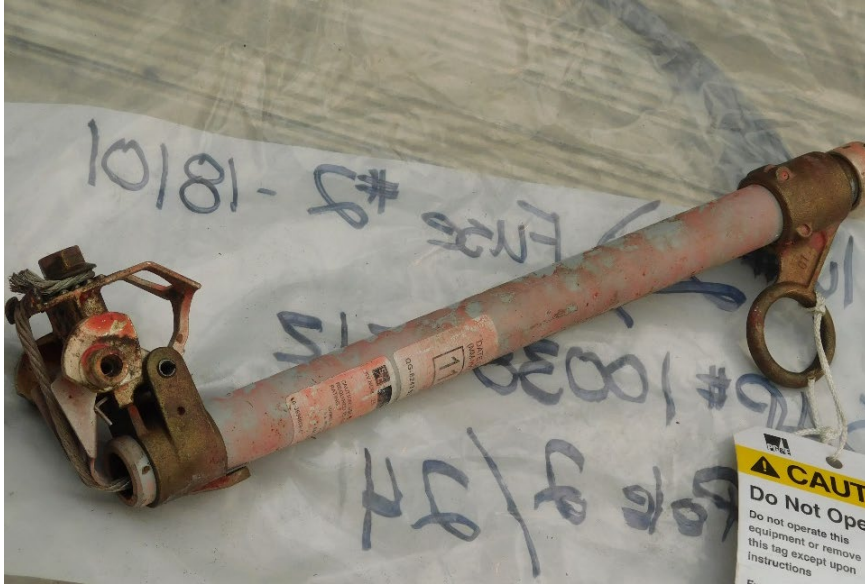
Figure 4: Second fuse does not appear to have blown.

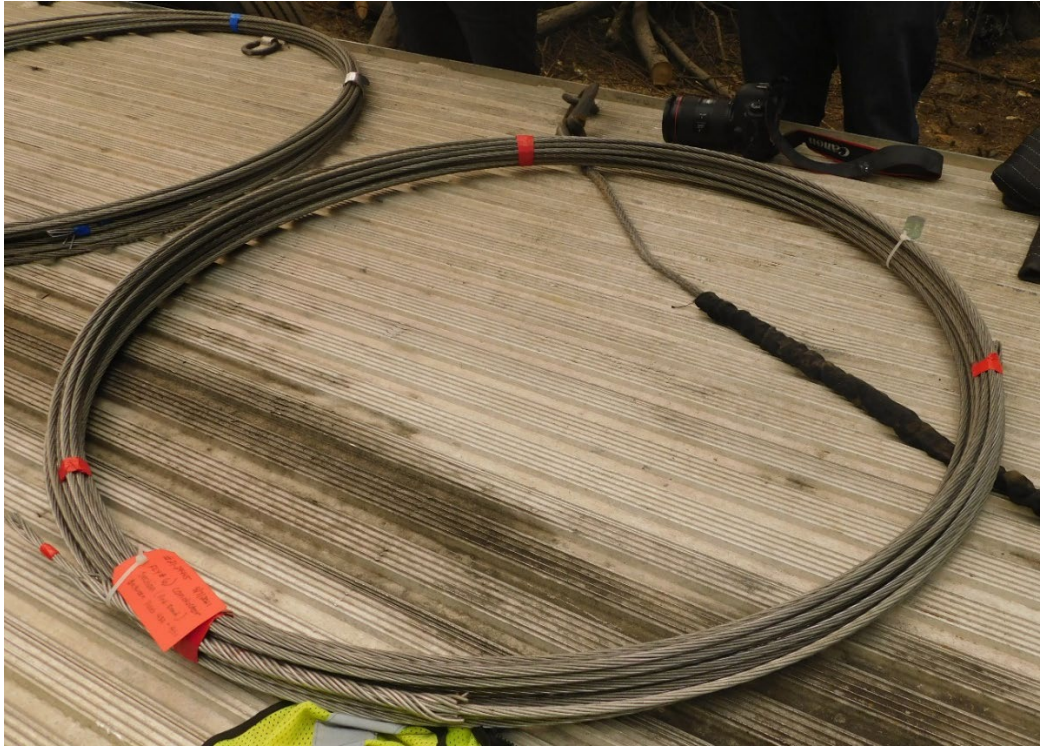
Figure 5: Two spans of conductor from pole 431 to pole 432.

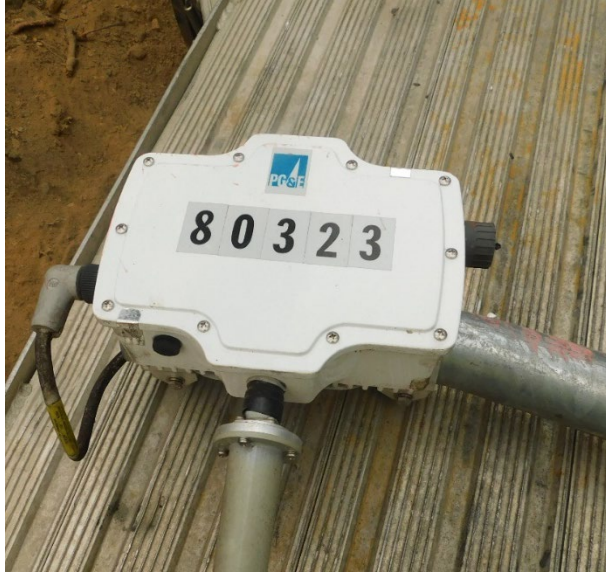
Figure 7: SmartMeter from pole 435.

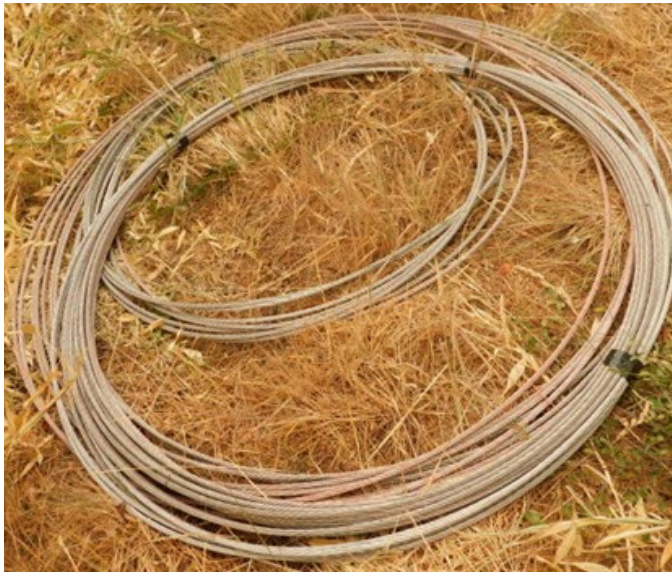
Figure 8: Conductor from poles 434 to 436.

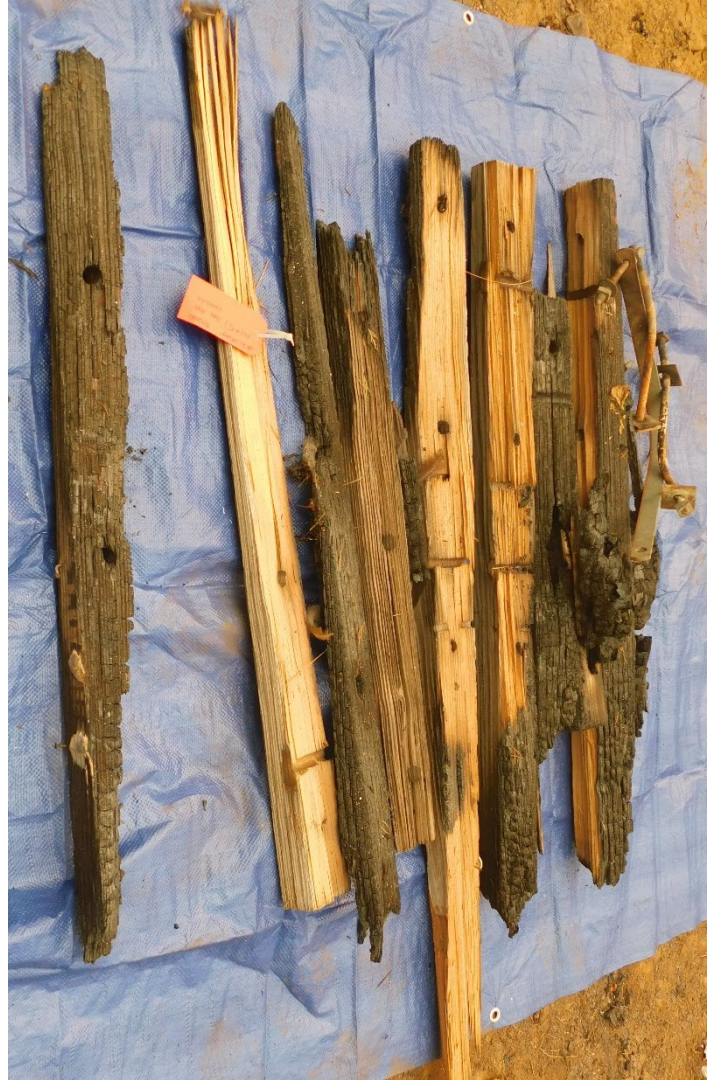
Figure 11: Crossarm remains from base of pole 433.

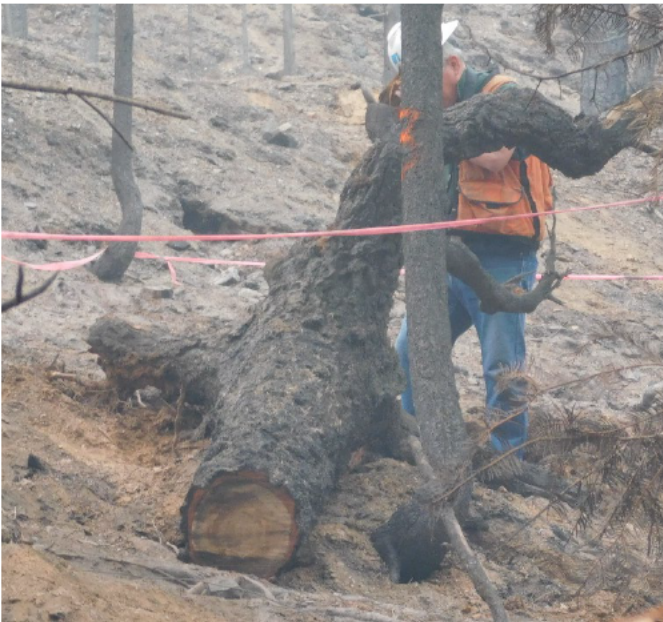
Figure 12: Base of Subject Tree (looking uphill).

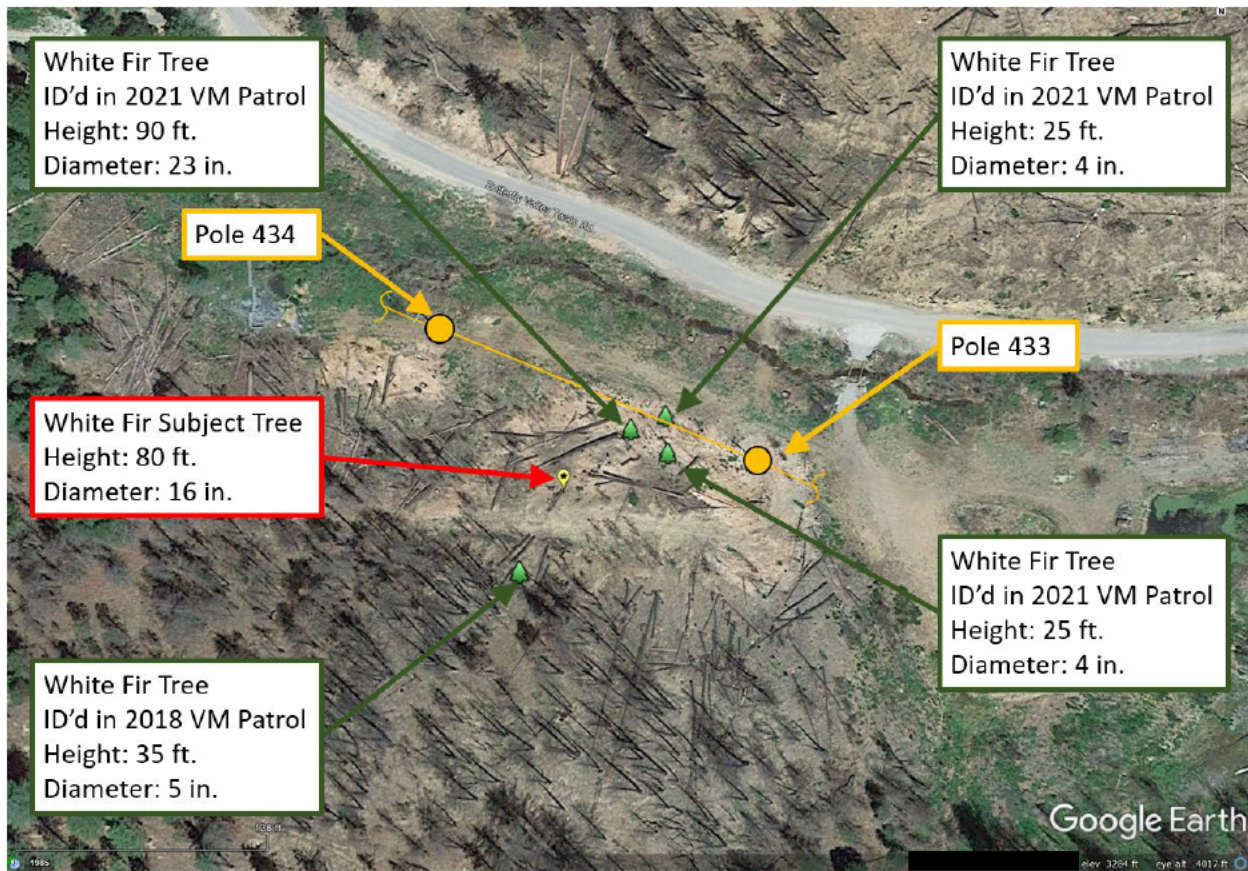
Figure 15: Location of White Fir Trees Identified in PG&E Vegetation Management Inspections, and the Location of the Subject Tree in Relation to the Incident Span.⁴¹
