## ATTACHMENT F: SAFETY BEST PRACTICES<sup>1</sup>

CONTENTS

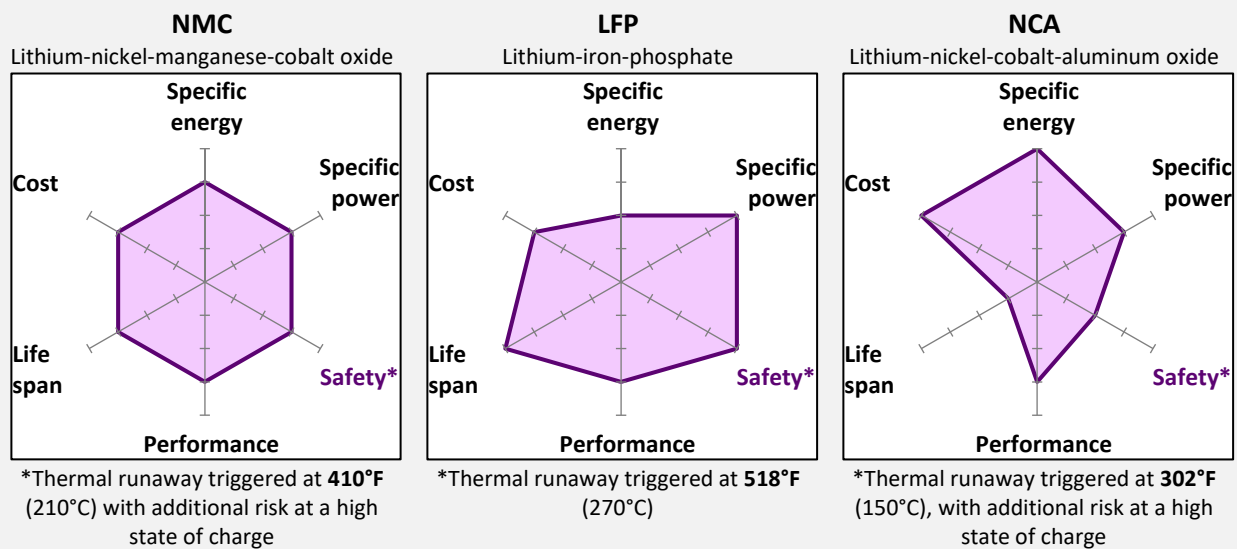
Figure 1: Key tradeoffs of lithium-ion battery chemistries.

Note: Higher score reflects more desirable characteristics, e.g., higher cost score means lower cost.  
 Source: Modified from (Cadex 2019) and using updated cost data from (Viswanathan et al. 2022).

In 2021 the dominant chemistry in global stationary battery energy storage markets—and in California’s stationary battery energy storage fleet—is **lithium-nickel-manganese-cobalt oxide (NMC)**. NMC measures relatively well across many dimensions, including energy and power ratings, safety, performance under heat and cold, life span, and cost. Thermal runaway is typically triggered at 410°F (210°C) with additional risk at a high state of charge (Cadex 2019). In practice, however, cost and supply chain issues with cobalt, plus rare but dramatic safety failures and public scares, have driven developers and electricity system planners to consider alternative chemistries. Wood Mackenzie projects NMC market share in global stationary energy storage to drop from 60% in 2020 to 30% in 2030 (Wood Mackenzie 2020).

**Lithium-iron-phosphate (LFP)**, by comparison, is projected to grow from 15% market share in global stationary battery energy storage in 2020 to 35% by 2030 (Wood Mackenzie 2020). LFP generally measures better in safety, power rating, and life span compared to NMC, with the tradeoff of a lower energy rating. Previously higher cost than NMC, LFP total installed costs dropped slightly below NMC by the end of 2021 (Viswanathan et al. 2022). LFP is more tolerant of full charge and high voltage, but it has higher stationary energy losses than NMC. Thermal runaway is typically triggered at a higher temperature of 518°F (270°C) regardless of state of charge (Cadex 2019). LFP is considered one of the safest lithium-ion chemistries.

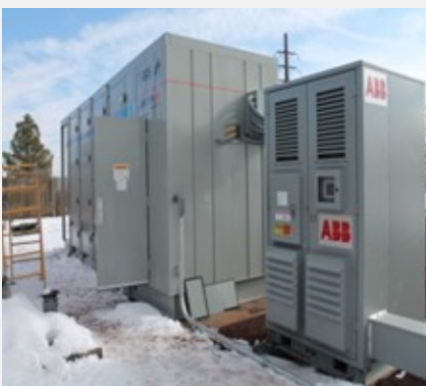
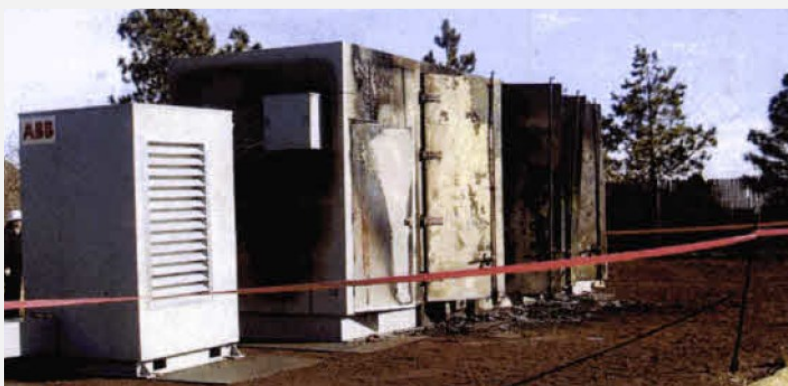
**Pre-Event**

**Post-Event**

In November 2012, after about 11 months of operations, the system was destroyed by fire and thermal runaway. The Flagstaff Fire Department observed 10–15' flames and smoke upon arrival to the site. Responders were initially instructed not to flow water within 50–75' of the fence housing the substation and they reported not being aware of the specific chemical hazards at the time. Flame lengths grew to an observed 50–75' during the event. Responder efforts were to prevent fire spread to nearby forested area, extinguish fire, and cool the equipment. One responder experienced chemical exposure upon removal of a safety mask. The fire department cleared and turned the site over to APS after about 1.5 hours.

An in-depth root cause analysis conducted by experts at Performance Improvement International (PII) did not determine exact cause but identified 5 primary factors (“failure modes”) that contributed to the event. Two out of five contributing factors involved component failures initiating the event. PII found (a) severely discharged cells below the minimum voltage threshold (a measure of state of charge) at the origin of thermal runaway, and (b) controller software and system design that allowed and continuously attempted charging of cells below that threshold. The system previously had a “near miss” with thermal runaway due to these two factors in May 2012 and PII found the issues were not resolved at the time.

Another two factors contributed to thermal runaway propagation through the battery system. Hardware design was one contributing factor, including issues with design of the water cooling system, water leakage, insufficient separation of cells, and inability to isolate individual banks. The presence of electric faults was another contributing factor, including material and placement of busbars that caused melting and ground faults that aided thermal runaway.

The fifth contributing factor created delays in responding to the situation. Inadequate monitoring—including no temperature alarm, no status signal on failed relays, no daily checks, and alarms going to unattended stations—prevented situational awareness needed to address component failures more proactively. It should also be noted that the system vendor and utility’s emergency response plan did not prepare first responders enough to understand the specific hazards of the site nor immediate course of action for containing the fire and cooling the equipment.

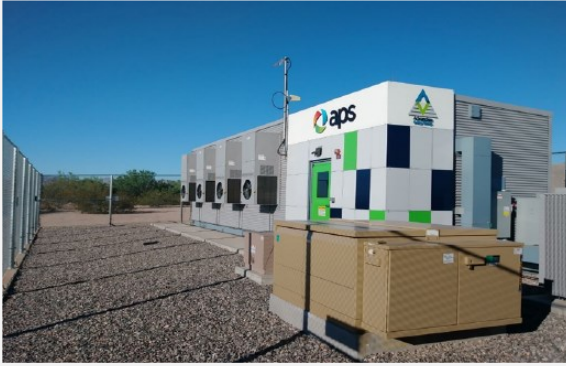
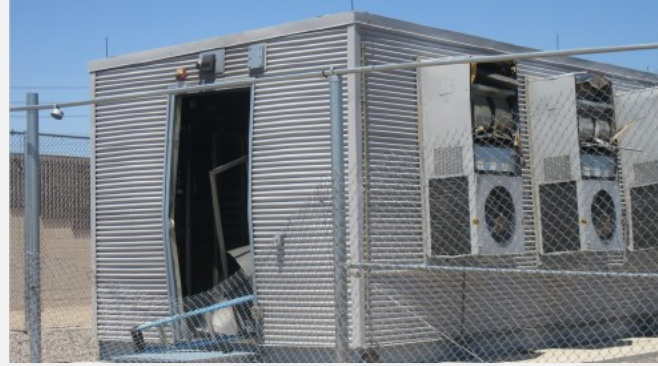
**Pre-Event**

**Post-Event**

In April 2019, after about 2 years of operations, the system was destroyed by rapid thermal runaway over the course of 3 hours followed by an explosion. The system's temperature monitor, laser-based Very Early Smoke Detection Apparatus (VESDA), and Novec 1230 clean agent gas fire suppression system reportedly operated and responded as designed. A passerby reported smoke about 45 minutes after VESDA registered an alarm condition and the Surprise Fire-Medical Department was dispatched. At about the same time the battery developer (Fluence) and APS apparently had notified authorities. The first fire engine arrived about seven minutes later (at 5:49 p.m.). The Fire-Medical team observed a toxic smoke emanating from the battery storage facility and called for backup. About 30–40 minutes later the Peoria Fire-Medical Department's HAZMAT team arrived. The HAZMAT team entered the fenced area several times to take readings and assess the situation. About 1.5 hours later (at 8:01 p.m.) they opened the door to the container and an explosion described as "a jet of flame that extended at least 75 feet outward and an estimated 20 feet vertically" severely injured four members of the HAZMAT team. Additionally, four members of the Fire-Medical team plus one officer from the Surprise Police Department were sent to a hospital for overnight observation for chemical exposure. Post-event assessments and cleanup at the site were particularly difficult as the storage system was at a high (90%) state of charge.

APS and LG Chem (the battery manufacturer) each commissioned technical analyses on the event which disagreed on the exact origin of thermal runaway. The APS analysis, conducted by DNV GL, found that thermal runaway was initiated by a voltage drop within one faulty battery cell. The LG Chem analysis, conducted by Exponent, rebutted this conclusion and instead found the cause to be a heat source external to the cells. A third analysis, conducted by Underwriters Laboratories (UL), did not address the topic of initial component failure and instead focused on emergency response and applicable design codes and standards. UL also issued a formal response to the DNV GL report to address inaccuracies it saw in DNV GL's description of the development process, scopes, and test methodologies of UL standards.

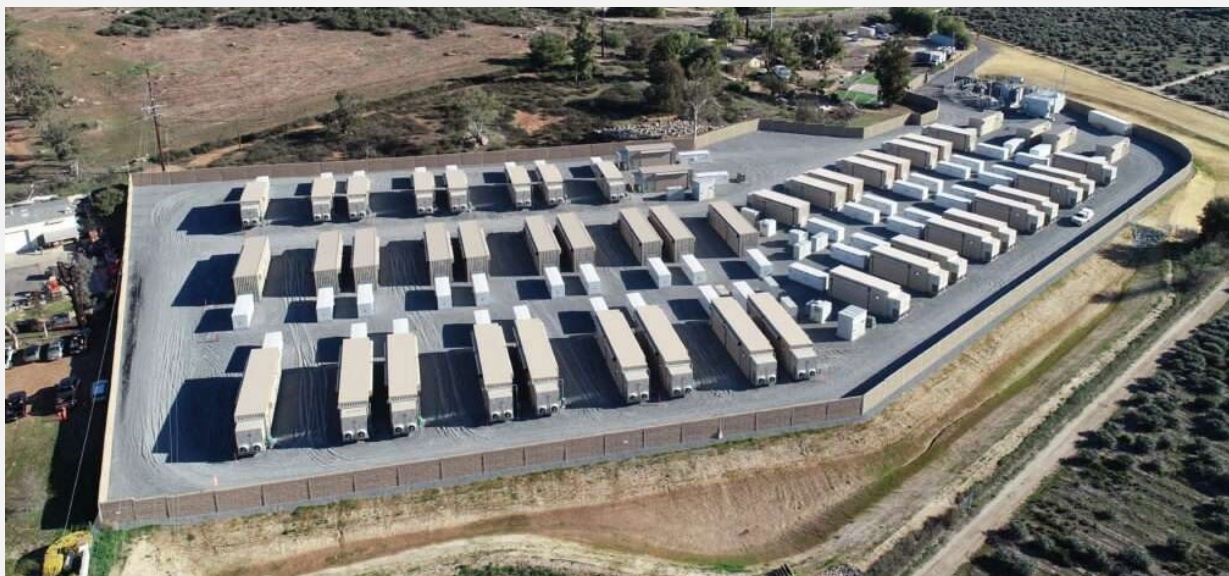
*Figure 13: Valley Center Battery Storage Project.*

Terra-Gen’s 140MW/560MWh lithium-ion installation came online in March 2022. The facility is designed as an outdoor array of containers (Figure 13). The project is contracted by SDG&E for system reliability purposes pursuant to the CPUC’s integrated resource planning proceedings.
