The Safety and Enforcement Division (SED) of the California Public Utilities Commission (CPUC) submitted a Notice of Probable Violation (NOPV) to San Diego Gas & Electric (SDG&E) related to its investigation of the Department of Transportation reportable incident #1268754, which occurred on August 22, 2019. Attached is SDG&E's written response to SED's NOPV.

DOT Reportable Incident (#1268754) that occurred on August 22, 2019

SDG&E Response:

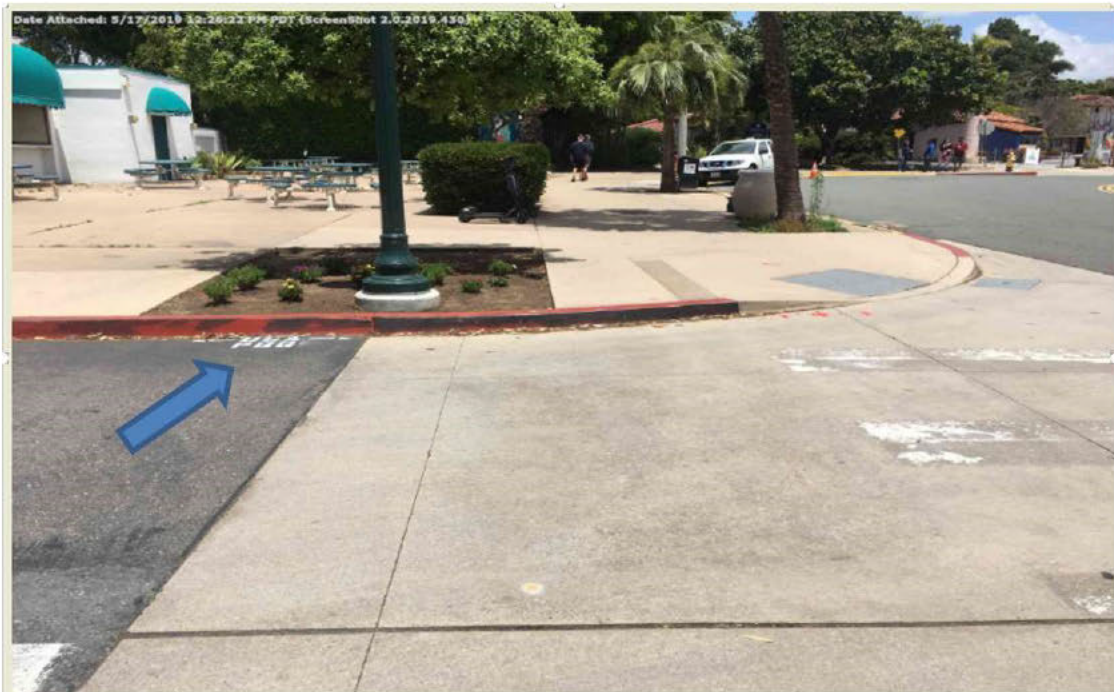
Image 3: Picture taken on Old Globe Way facing North at intersection of Village Place on May 17, 2019 during mark out. PGB USA mark stenciled to left of light post. This

picture is for Naton Engineering's USA Ticket #A1912341234, which is approximately 300 feet from incident area.

In SDG&E's post incident investigation Naton Engineering provided USA Ticket #A1912341234 and claimed their excavation was authorized under the USA Ticket #A1912341234. Delineations for USA Ticket #A191341234 were provided under the initials "PBG" for Naton Engineering's general contractor, Pacific Building Group. (Please see Images 1, 2, 7, 8 and 9 below for pictures showing USA Ticket #A1912341234 detail report and "PBG" delineations). Thus, the Utiliquest employee did not need to communicate with the excavator as he marked according to "PBG" delineations and USA Ticket #A191341234 information. Naton Engineering damaged the gas service line more than 300 feet from the work location as described on USA Ticket #A191341234 and the delineations under "PBG" (See Images 3 and 4 below).

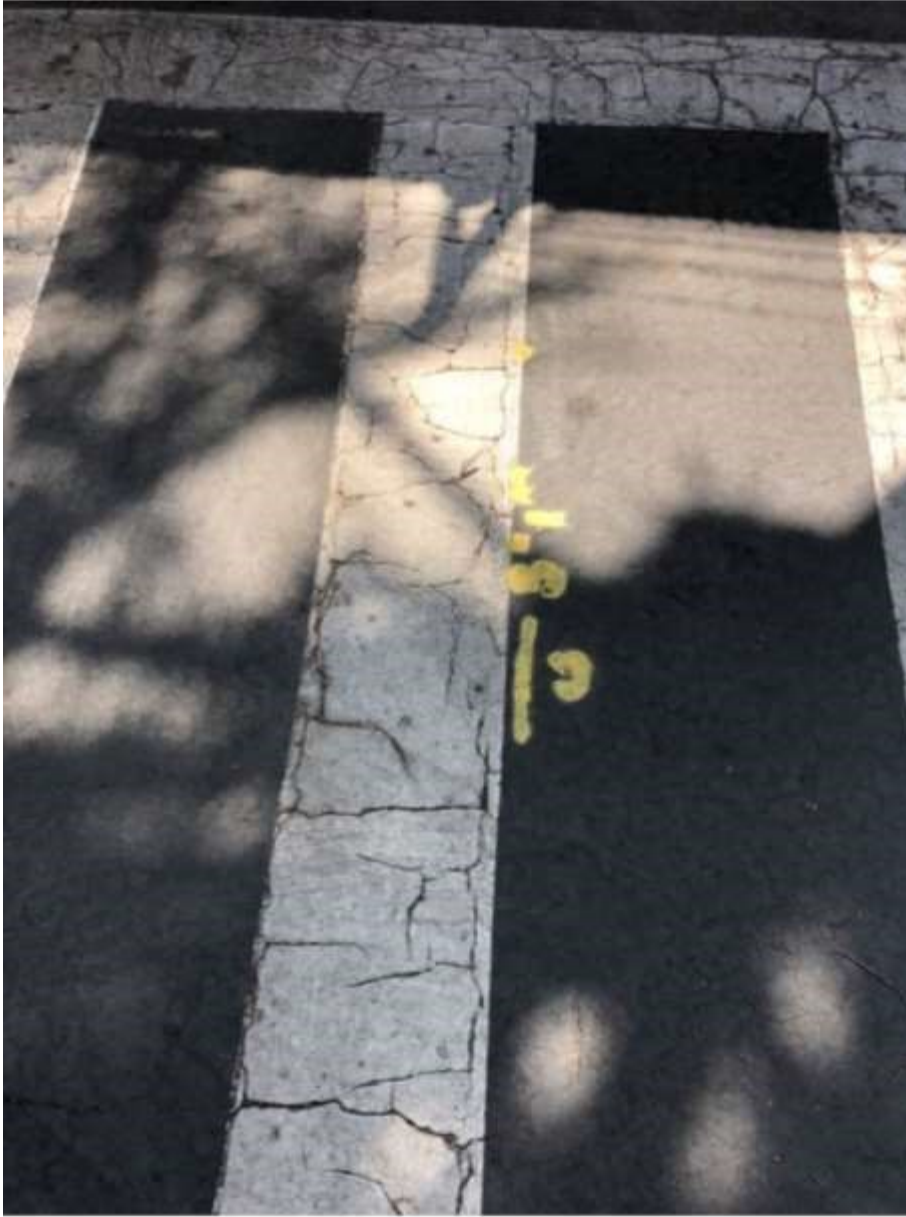
Image 7: Marks in area described on expired USA Ticket #A191060668 believed to be provided by Cable, Pipe and Leak locating employees.

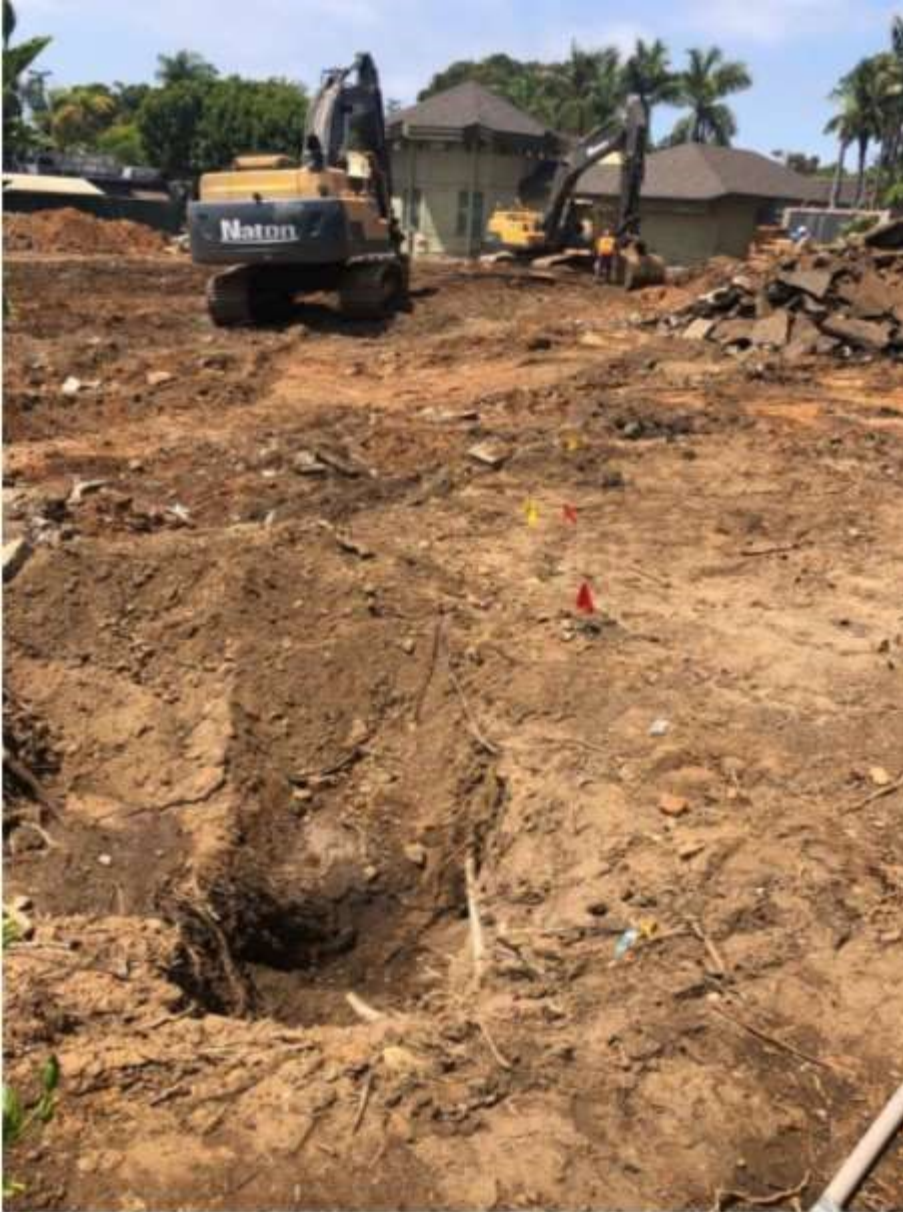
Image 8: Flags in area described on expired USA Ticket #A191060668 labeled Cable, Pipe and Leak.

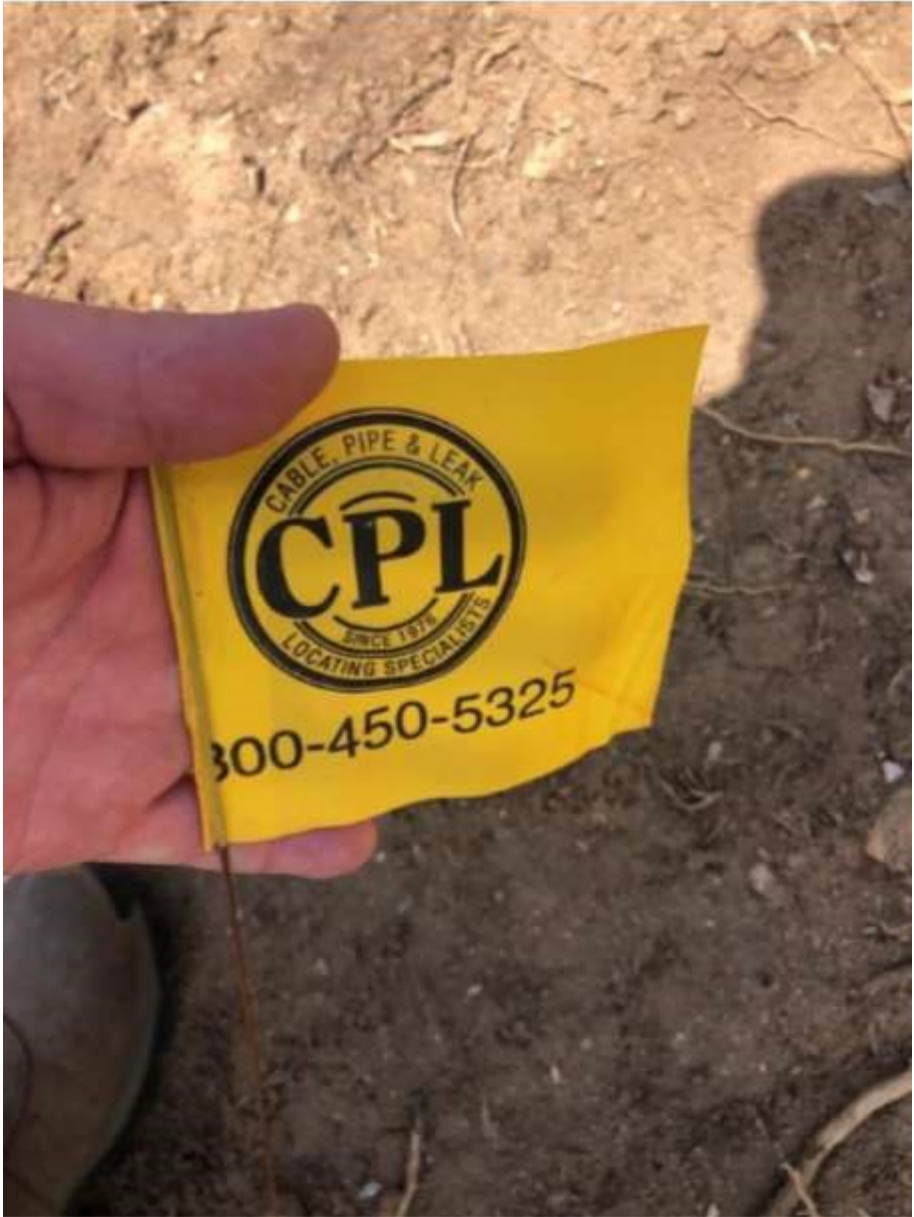
Image 9: Close up of Cable, Pipe and Leak Flag.
