**ANNUAL RAILROAD SAFETY REPORT  
TO THE  
CALIFORNIA STATE LEGISLATURE**

**November 30, 2018  
for  
Fiscal Year 2017 - 18**

**CALIFORNIA PUBLIC UTILITIES COMMISSION  
SAFETY AND ENFORCEMENT DIVISION  
OFFICE OF RAIL SAFETY  
RAILROAD OPERATIONS AND SAFETY BRANCH**

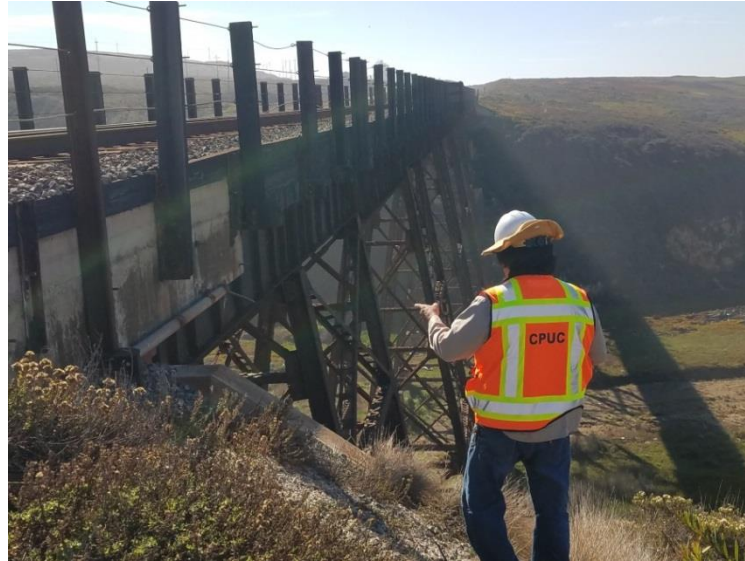
*CPUC railroad safety bridge inspector looking over ballast deck bridge substructure for structural integrity and associated potential risks*

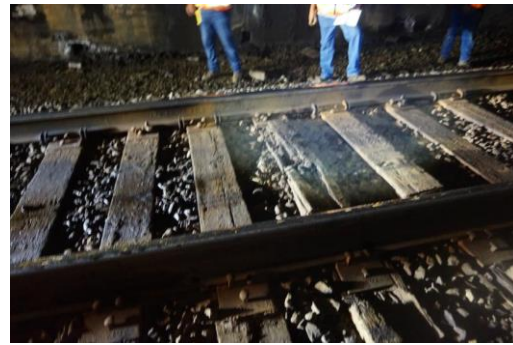
On June 13, 2018, CPUC inspectors surveyed two UPRR tunnels (Tunnels 33 and 34) east of Colfax near Cape Horn. The survey identified loose spikes in the wooden ties securing the rails in Tunnel 33. UPRR management was present during the survey, and UP personnel removed the loose spikes, inserted wood plugs, and re-spiked the ties. The inspectors saw a groove in the ceiling of Tunnel 34 that indicated that the ceiling had been struck by a train. However, this was not considered to require remediation.

*Loose spikes found in tunnel 33*

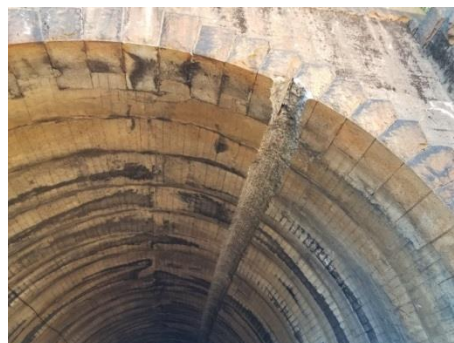
*Groove in ceiling, UPRR Tunnel 34*

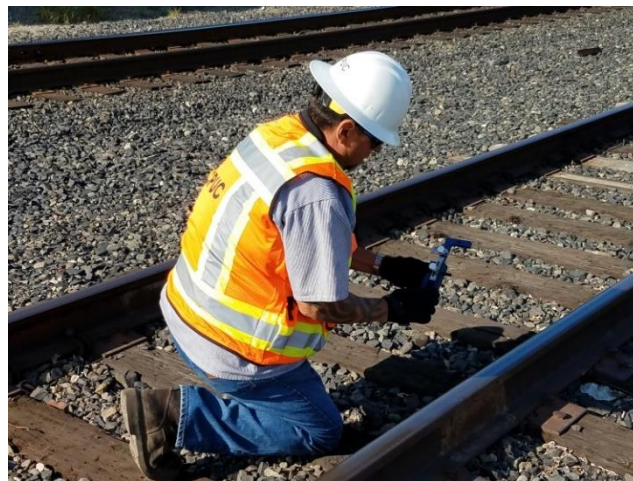
*A CPUC inspector reading rail gage measurements*

CPUC plans to continue its collection of head wear information and, based on this evidence, advocate for effective rail head wear management policies by railroads. This goal is consistent with the Office of Rail Safety's practice of looking beyond the regulations. This ongoing project has already allowed the CPUC to make railroads aware of the risks associated with some of their currently-existing rail replacement plans and thus has had a positive impact on rail replacement management by some railroads.

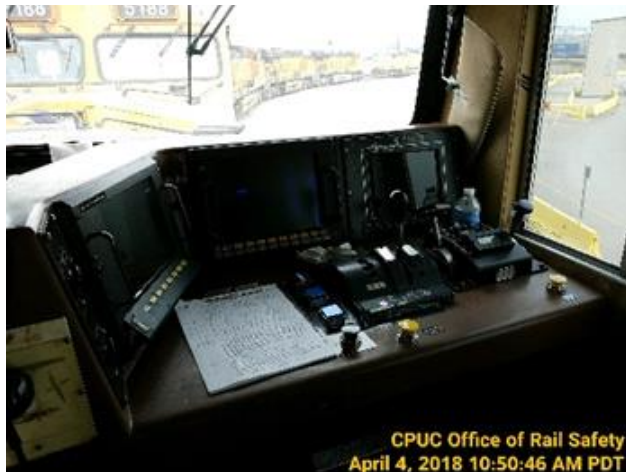
*A BNSF Locomotive operating console with PTC screen on the right side*

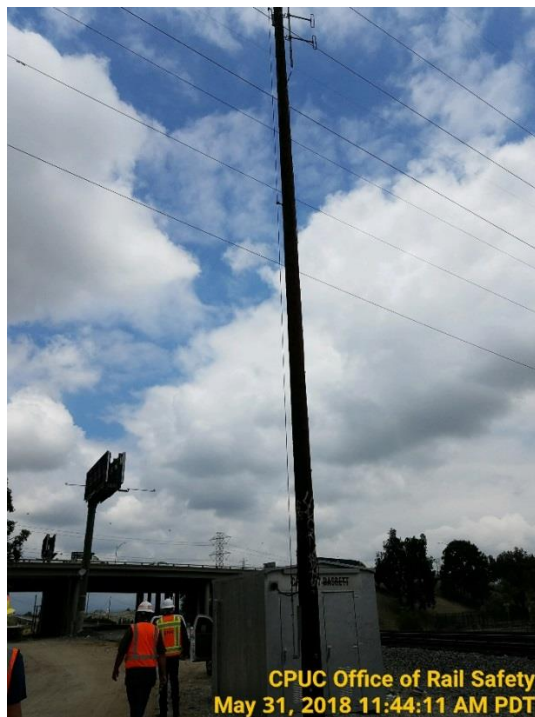
*A CPUC inspector observed a UPRR PTC wayside installation and associated PTC radio equipment. PTC antennas are shown on the top of the pole.*

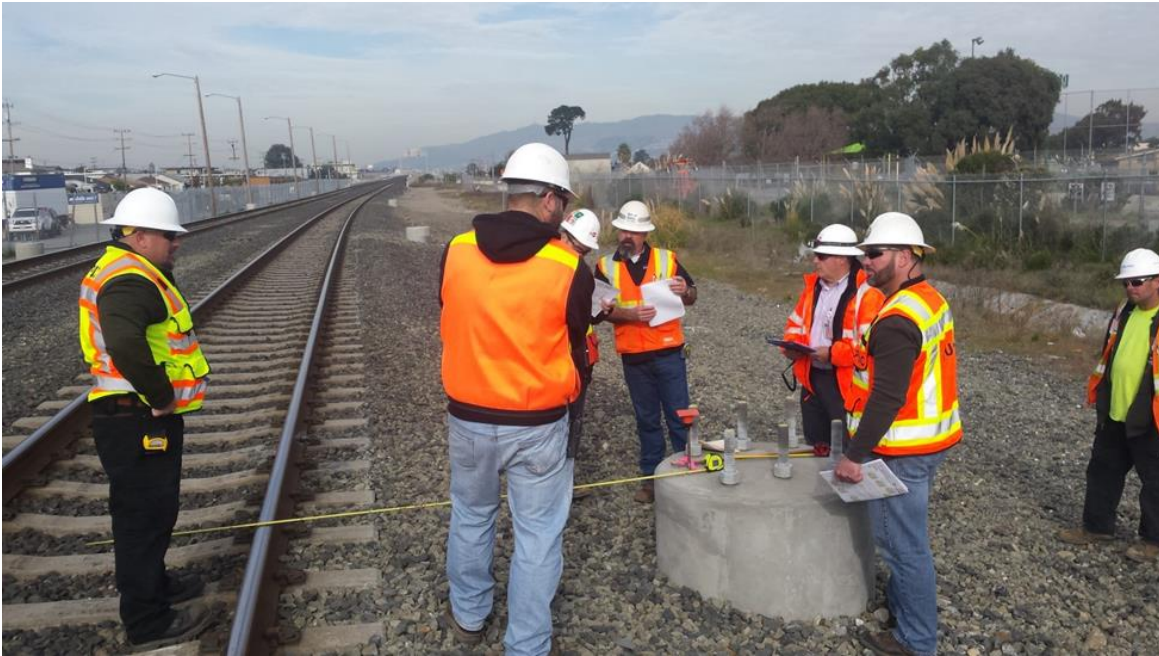
*CPUC and Caltrain personnel inspecting in San Bruno at one of the new foundations that will support the upcoming electrification*

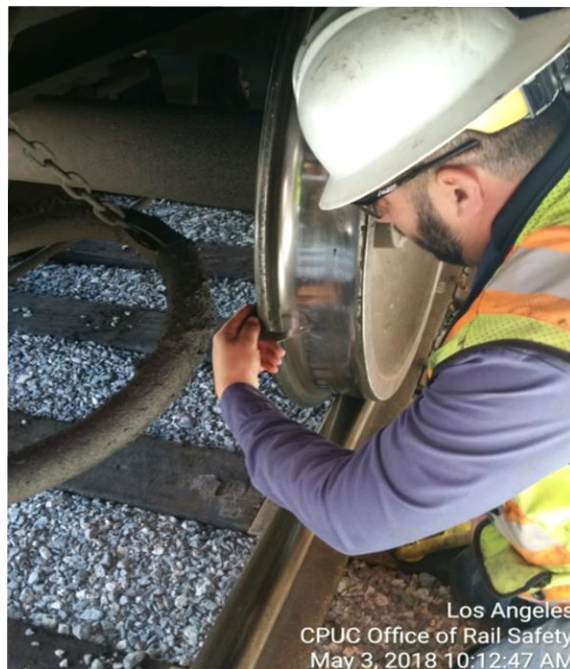
*CPUC MP&E inspector measuring a wheel flange*

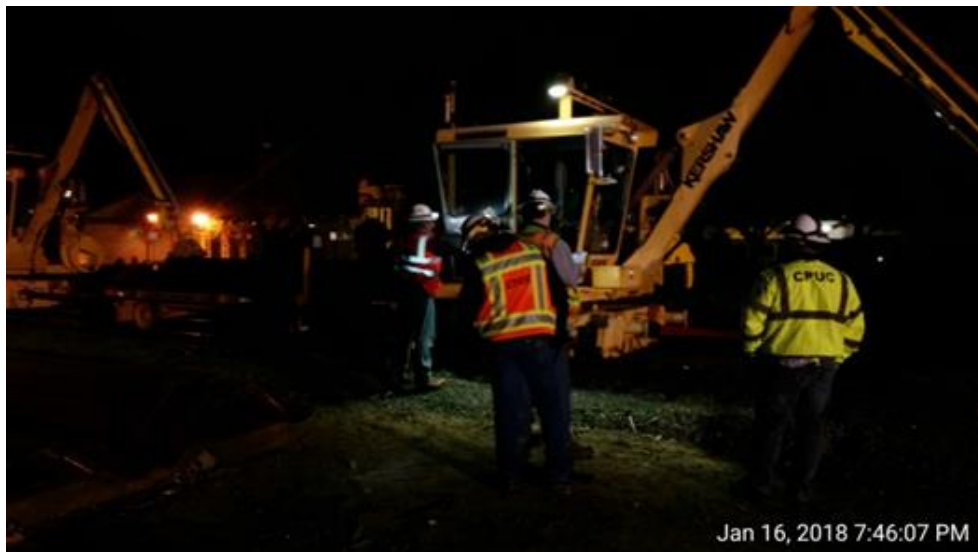
*CPUC inspectors inspecting a tie crane at night during a focused inspection for operable change-of-direction alarm*

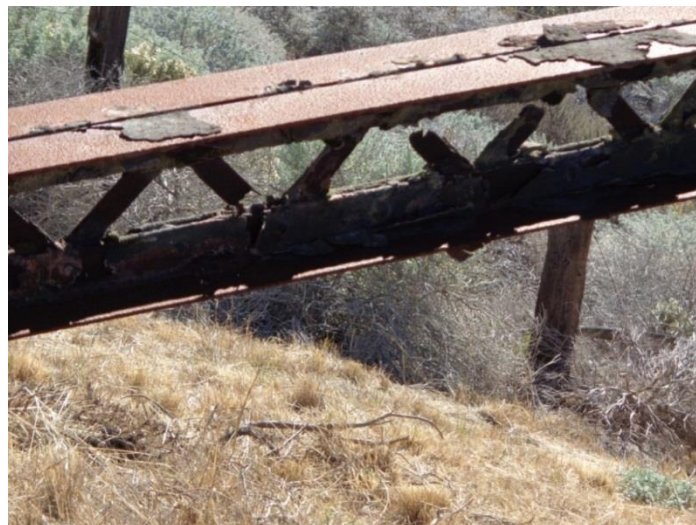
*Deteriorated steel on a UPRR bridge, Vandenberg Air Force Base*

CPUC inspectors had discussions with the UPRR Structures Department staff and informed them that this concern was being documented by the RMSR process. Through these discussions, it was determined that the bridge is still structurally sound and can host train movements. However, UPRR staff did inform the CPUC inspectors that the bridge will be replaced in the year 2020.

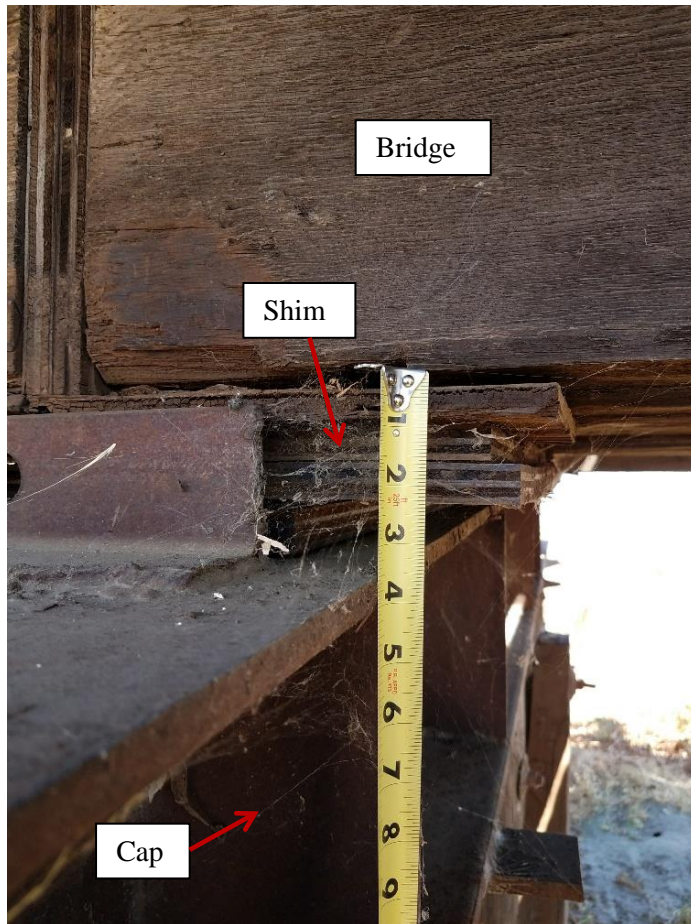
*Deteriorating shims compounding out of level condition under bridge*

The SJVR was notified of the conditions identified, and informed SJVR that this concern was being documented on the RMSR form. Through these discussions regarding the bridge concerns identified by CPUC inspectors, the railroad replaced the shims and will perform weekly inspections to ensure the bridge’s integrity until such time as the piles and cap can be replaced. The railroad will make permanent repairs to the piles and cap in 2019 under their capital project plan.

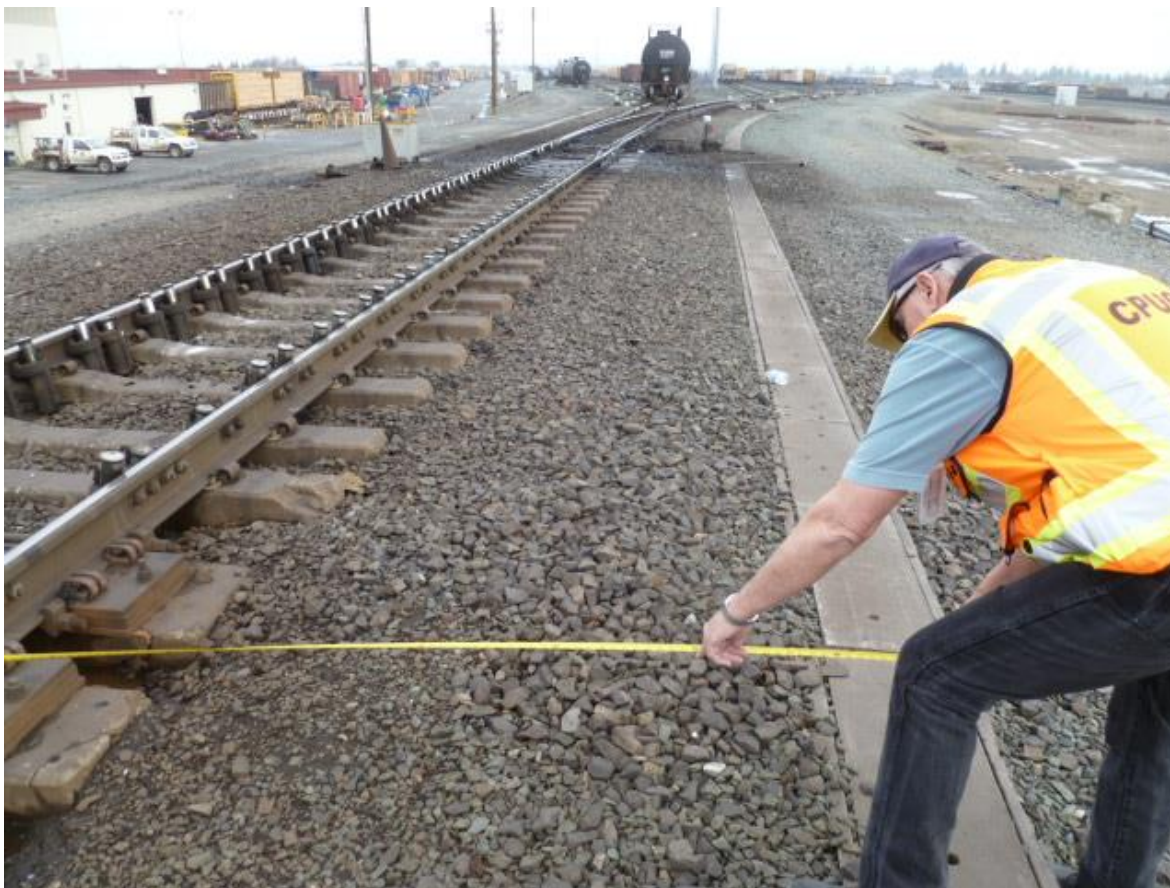
*CPUC Inspector measuring walkway distance from track center*

Large ballast, as described above, is difficult to walk on and can lead to injuries to railroad workers if they slip, trip, or fall due to the large ballast. In addition, during certain operations, railroad workers perform strenuous actions, consistent with normal trackside duties, alongside railroad cars. If workers were to lose their foothold in the walkway, due to stepping on oversized ballast while working next to moving railroad cars, they could fall into the moving railroad cars and suffer serious personal injuries.

The two CPUC Inspectors found that these conditions had been previously reported to UPRR management by other CPUC staff. A report of the findings of this inspection, including pictures of the non-compliant conditions, was sent to the UPRR Senior Manager of Terminal Operations and the UPRR Senior Manager of Road Operations. A follow-up inspection was made on January 18, 2018 by the CPUC Operating Practices inspector, who discovered that the unsafe condition had not been remediated. CPUC staff contacted the appropriate railroad manager again, insisting on remedial action. An additional follow-up inspection was conducted soon thereafter, which found that all non-compliant conditions had been corrected.

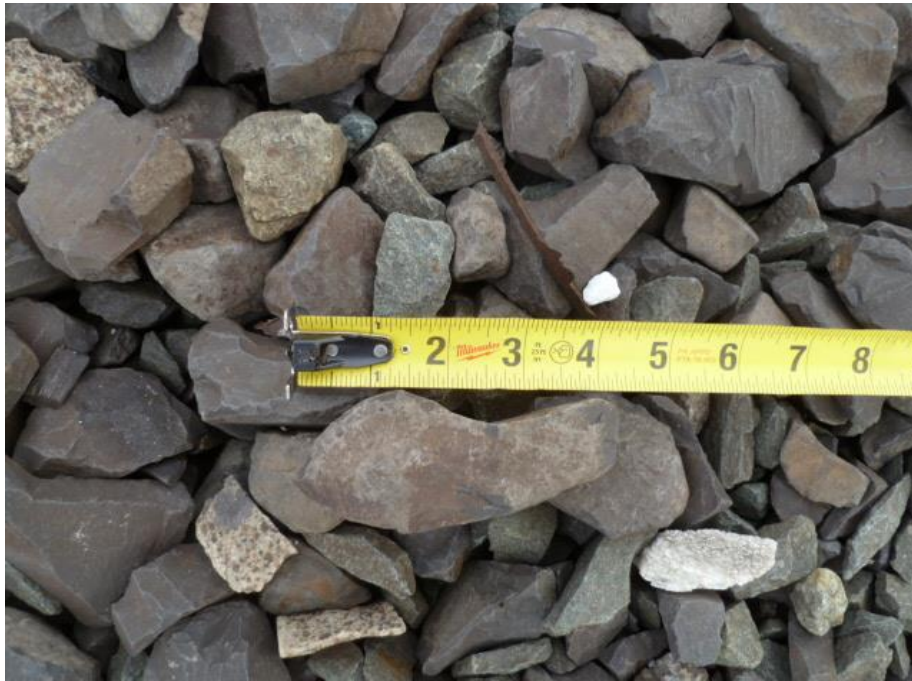
*Oversized ballast, which creates a tripping hazard.*

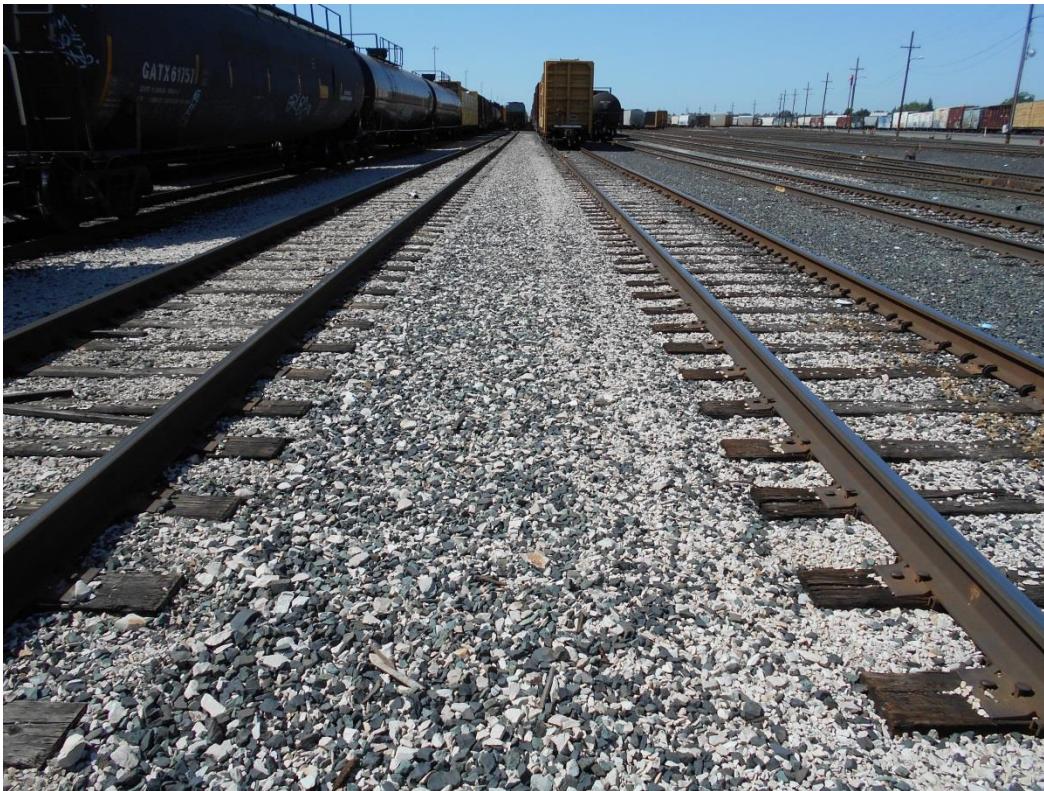
*Oversized ballast location after large ballast removal; replaced with ballast complying with GO 118-A.*

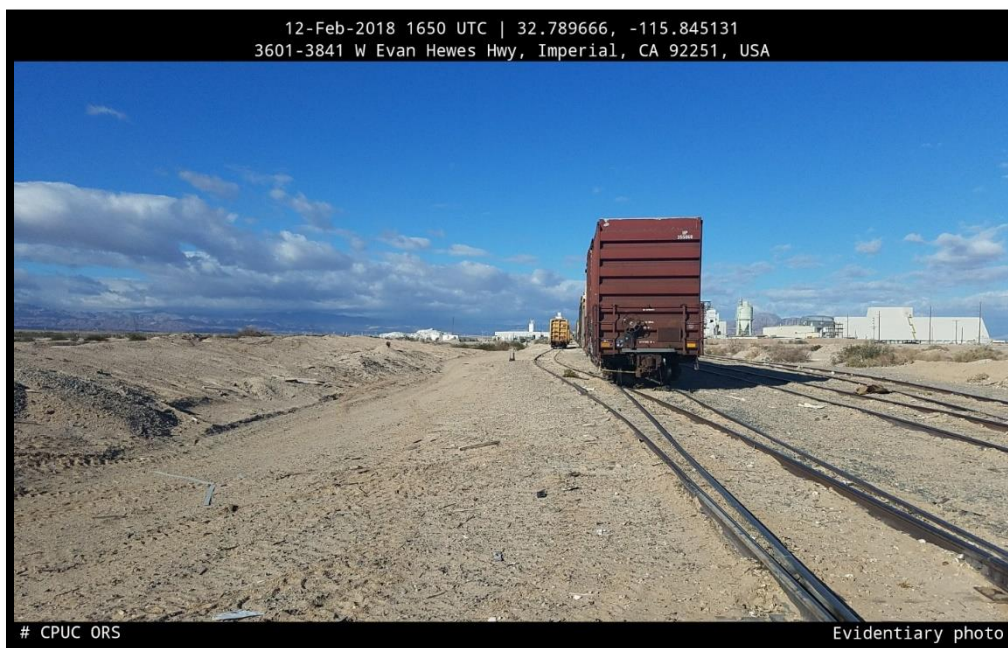
*Railcar blocking access to an adjacent track*

UPRR Management was immediately notified of this condition by the CPUC inspectors. Due to the severity of this situation, a violation with an assessment for civil penalties was recommended to FRA. UPRR management acted immediately to move the cars to a safe location. CPUC inspectors returned to this location on March 12, 2018 for a follow up inspection. No fouling conditions were observed.

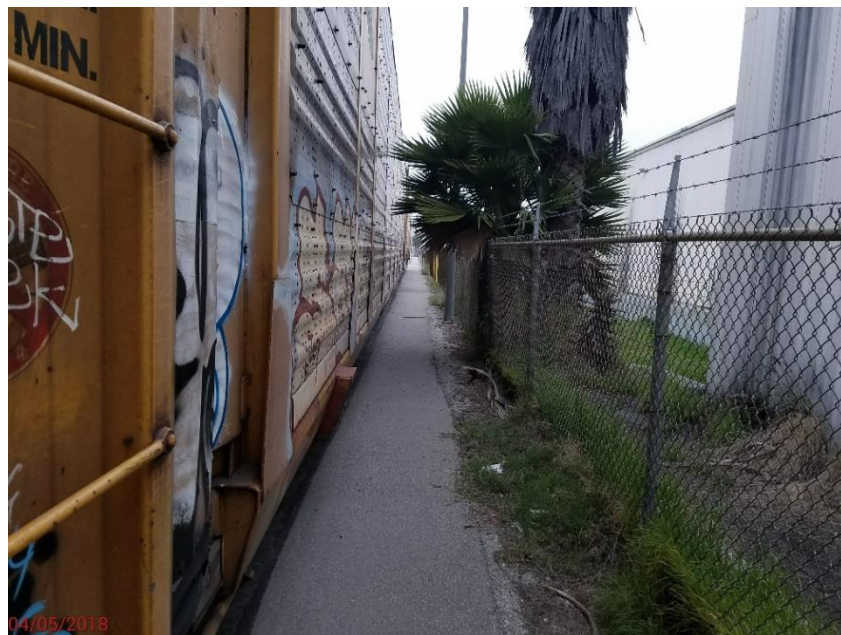
*Vegetation impeding side clearance*

After being notified by the inspectors, PHL personnel cut back the vegetation to ensure that it would not come into contact with employees riding on rail cars. A follow-up inspection by CPUC personnel verified that the issue had been mitigated.

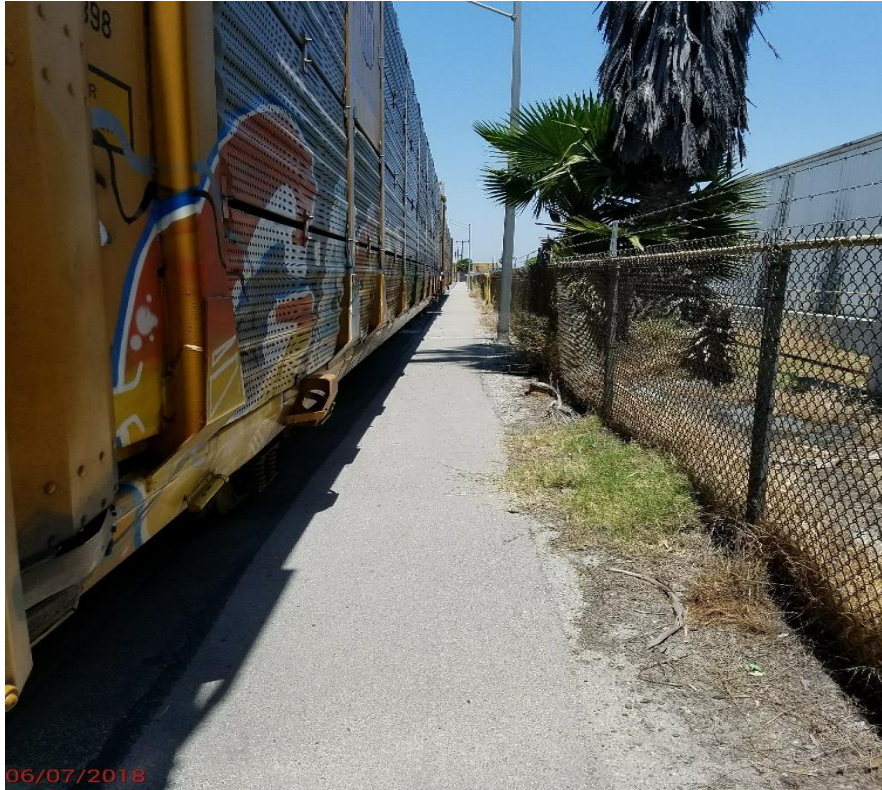
*Side clearance after vegetation removal*

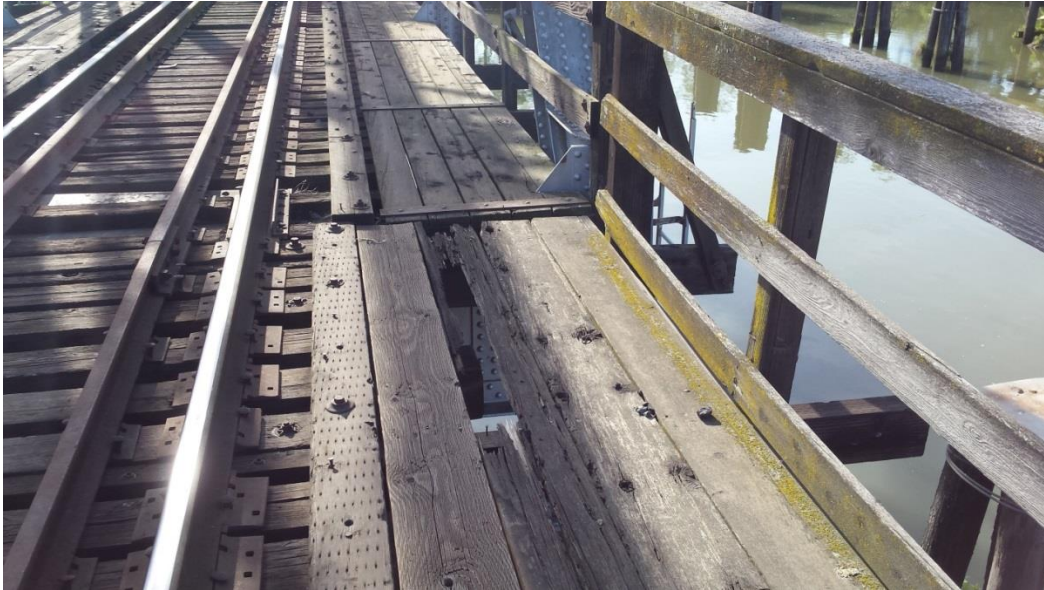
*Unsafe walkway on the San Joaquin River Bridge*

The CPUC inspector notified a CCT manager regarding the condition. CCT personnel placed caution tape around the hazard as a temporary safety warning measure and put out a notice to employees regarding the danger. The walkway timbers were replaced the next day. The CPUC inspector performed a follow-up inspection and verified that all repairs had been made.

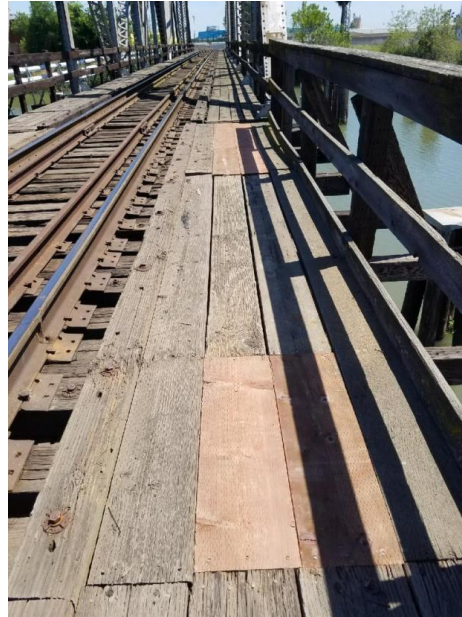
*San Joaquin River bridge walkway after repair*

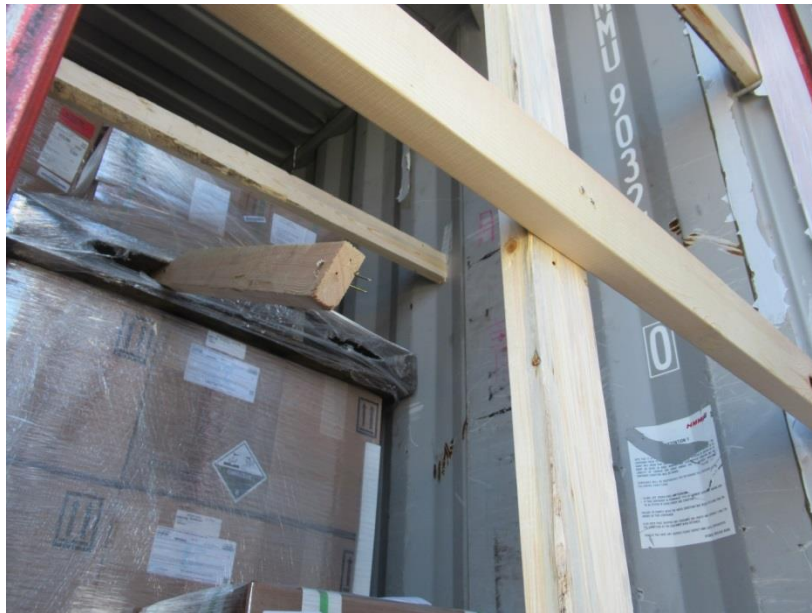
*Failed blocking and bracing of hazardous materials containers*

The shipper was responsible for the defects, and arranged for their remediation. The inspectors recommended to the shipper that it implement better training of its personnel responsible for hazardous materials shipments.

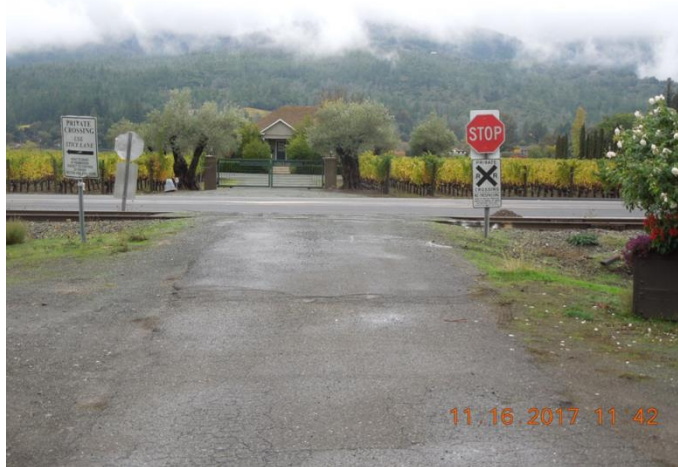
Based on the above information, the cause was due to error by the van operator. CPUC staff concluded that there were no violations of railroad operating rules or of state or federal regulations by the train crew.

*View of private crossing as seen from east to west, the direction the van was traveling (signs replaced after incident)*

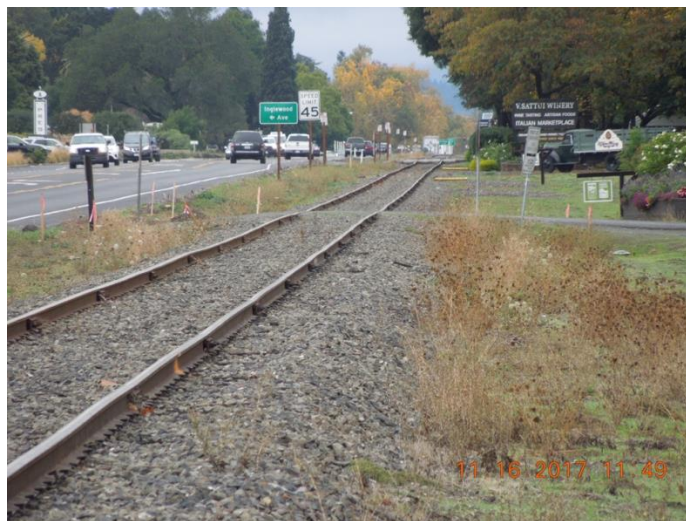
*View of private grade crossing as seen from south to north, the direction the train was traveling*

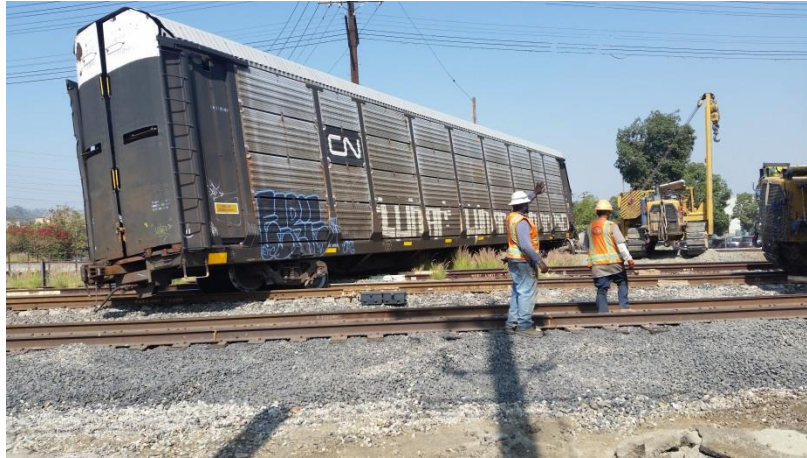
CPUC inspectors determined the root cause of the derailment to be mechanical failure of the stabilizing rod on one of the derailed auto racks.

*Derailed auto rack train car*

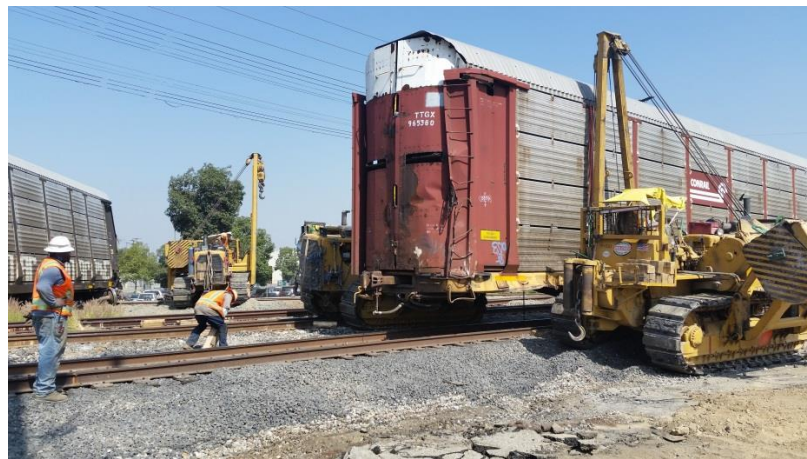
*Auto rack being re-railed*

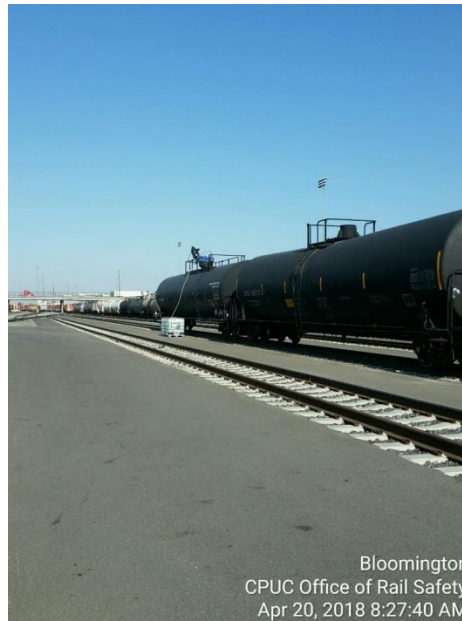
The CPUC and FRA inspectors identified two non-compliances of FRA regulations. Both the sample line valve (liquid) and vapor valve (air), as used on the vapor recovery system, were not “tool tight” (i.e., tightened with an appropriate tool, and unable to be moved by bare hands). The failure to properly tighten the valves was the responsibility of the shipper, rather than the railroad. As described above, the defective valves had to be replaced. The sample line valve issue was cited as an FRA defective condition, but the vapor line valve defect was an FRA recommendation for civil penalties, due to the more serious nature of the commodity venting into the atmosphere and creating a serious inhalation risk.

*Vapor control system attached to sample line of the anhydrous ammonia car*
