CALIFORNIA PUBLIC UTILITIES COMMISSION
Safety and Enforcement Division

Electric Safety and Reliability Branch

Incident Number: E20191027-02

Summary of Incident: A fire occurred along Camino Diablo Road and damaging a nearby sports club. The Incident involved a broken pole, wires down and a failed transformer. Based on information from Contra Costa County Fire Protection District (CCCFPD), it is likely that the transformer failed, resulting in the fire and the downed wires/pole.

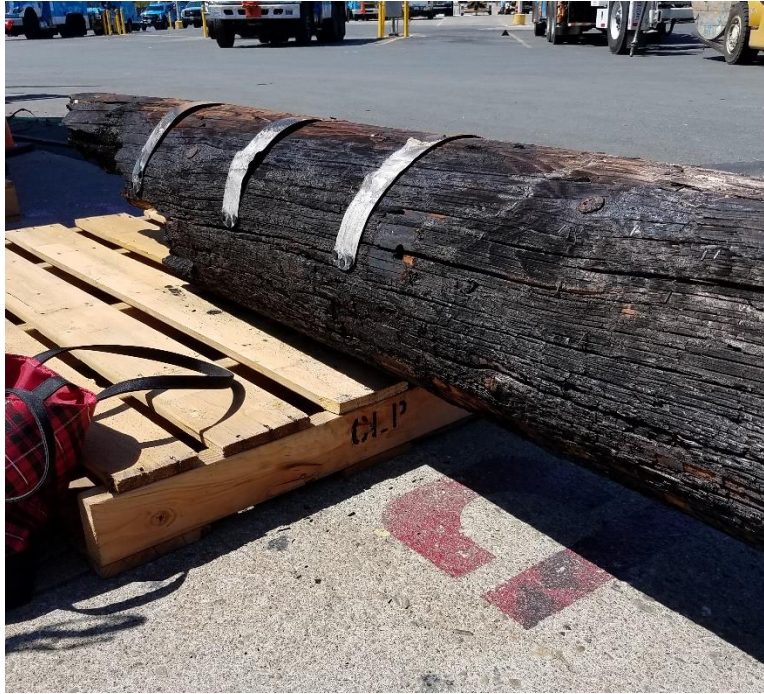
On June 23, 2020 SED staff viewed the evidence collected by PG&E at its service yard in Concord. During the evidence viewing SED noted that the segment of Pole 1 that had failed appeared to have a hollow cavity. However, it is unclear if that cavity shown in Figure 1 and Figure 2 was created by the pole's structural failure and burning, or if it was

present prior to the incident and was not detected during PG&E's inspections.²

Figure 1: Segment of Pole 1. This appears to be the point of failure.

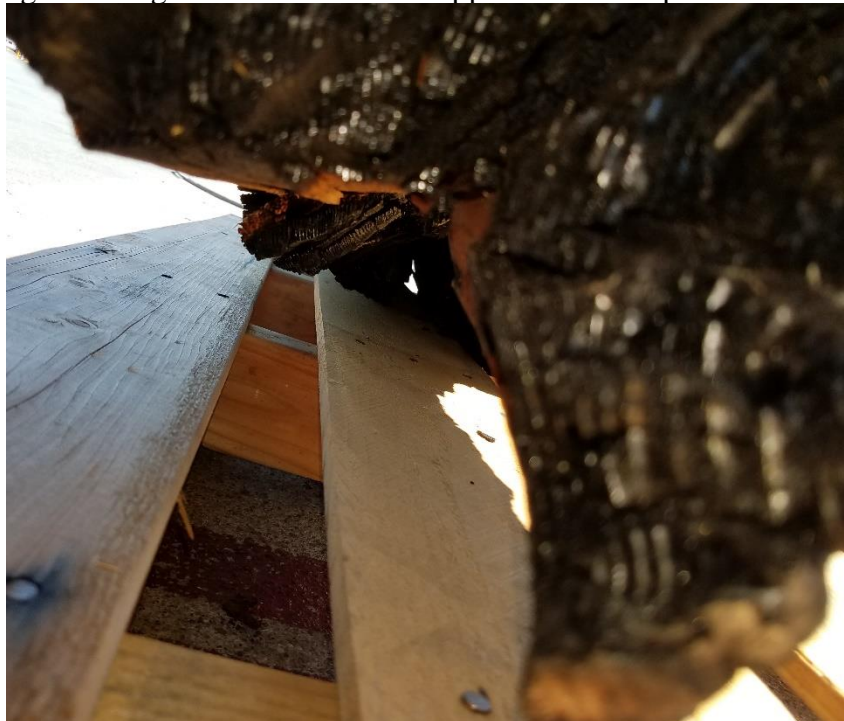
Figure 2: Interior view of failure point of Pole 1.

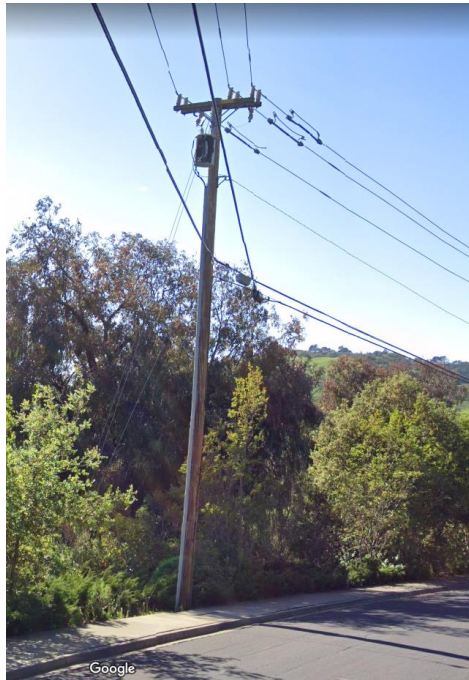
Previous inspections and patrols of the Incident Poles showed no indication of issues with the Poles 1 and 2 or their respective equipment. PG&E inspected Pole 1 in September 2015 and August 2005. Both inspections were treat and test inspections. In the 2015 inspection, no issues were found with Pole 1 and the top of Pole 1 was deemed to be in “Fair” condition. Additionally, the Figures 3 and 4 above show that the pole’s external condition is in alignment with the latest test and treat inspection.

Figure 3: Google maps of Pole 1 dated April 2019

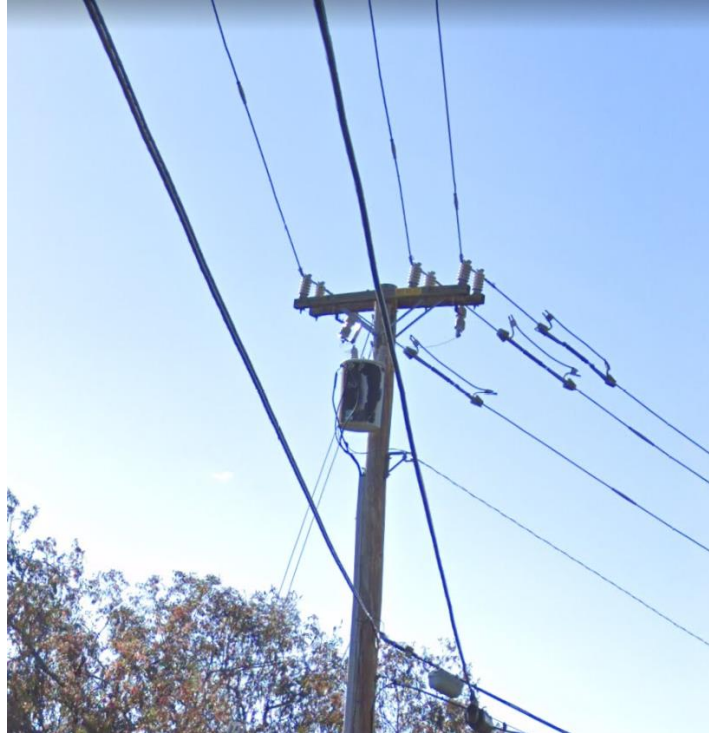
Figure 4: Google maps of Pole 1 dated April 2019
