CALIFORNIA PUBLIC UTILITIES COMMISSION
Safety and Enforcement Division
Electric Safety and Reliability Branch

Incident Investigation Report

Incident Number: E 20191030-05

Location of the Incident: 200 Block of West Los Angeles Avenue
Simi Valley, CA
County: Ventura

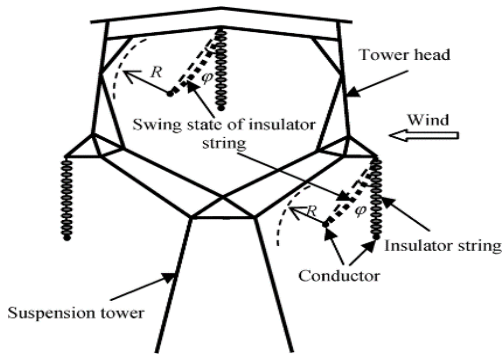
Figure 2: Suspension Insulator with swing angle⁴

Suspension insulator strings supporting transmission conductors, either at tangent or angle structures, are usually free to swing about their points of support. Therefore, it is necessary to ensure that when the insulators do swing, clearances are maintained to structures and guy wires.³

In a letter dated December 14, 2020, SCE stated that they determined the maximum swing angle of suspension insulators by designing the structure and insulators with a Computer-Aided Design (CAD). They do so by rotating the insulator until the energized portion of the insulator encroaches the minimum allowable clearance in GO 95 Tables 1 & 2. The swing angle is measured from the plumb centerline of the insulator to the swung portion of the insulator. Additionally, structure geometry, span length, weight span, wind span, insulator weight, insulator geometry, wind pressure, line angle, horizontal tension, and similar factors are also considered.
