**Bear Valley Electric Service, Inc. (BVES)**

**2022 Annual Electric Reliability Report**

**July 17, 2023**

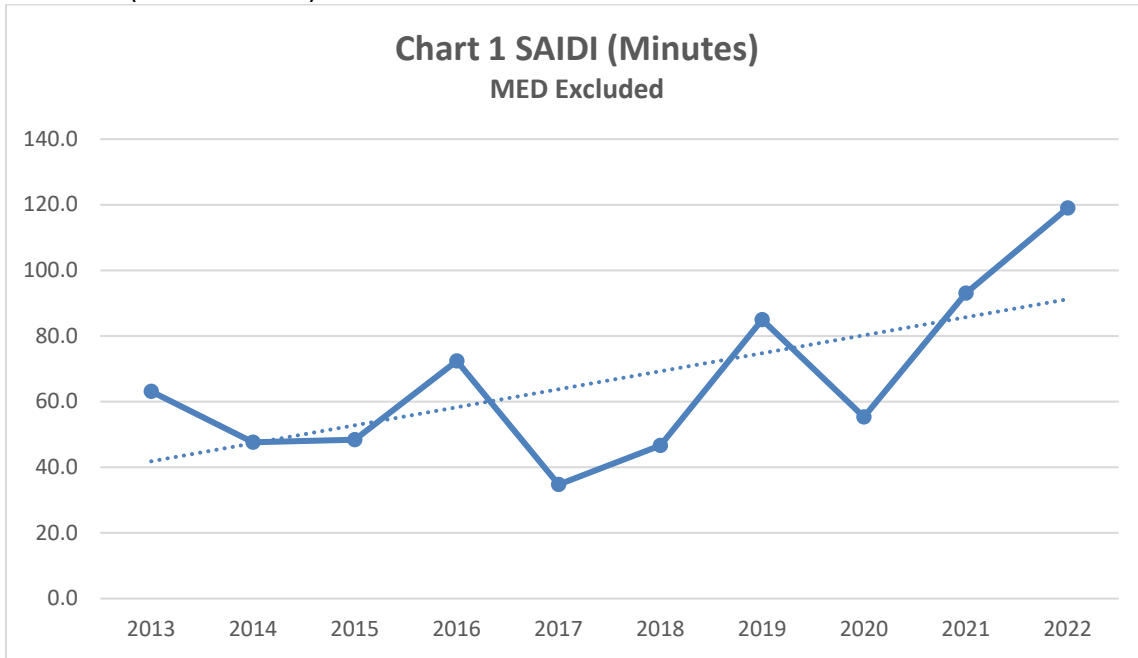
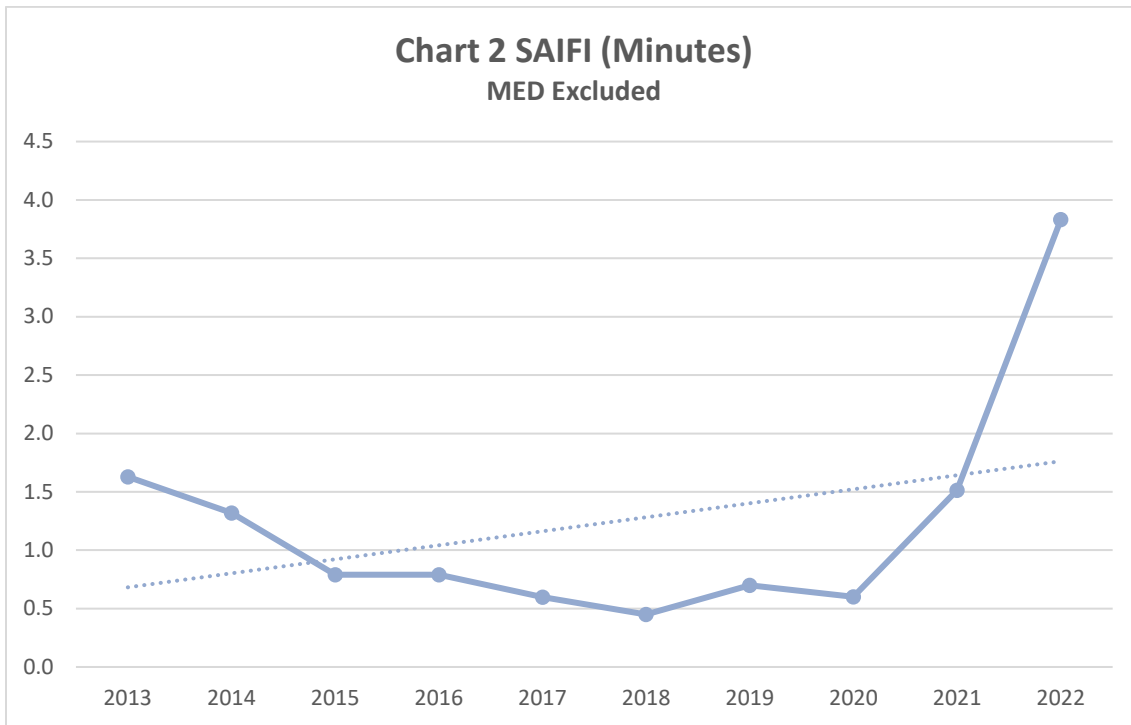
Charts 1 through 4 provide line graphs of SAIDI, SAIFI, MAIFI and CAIDI for the past 10 years with linear trend line (MED Excluded).

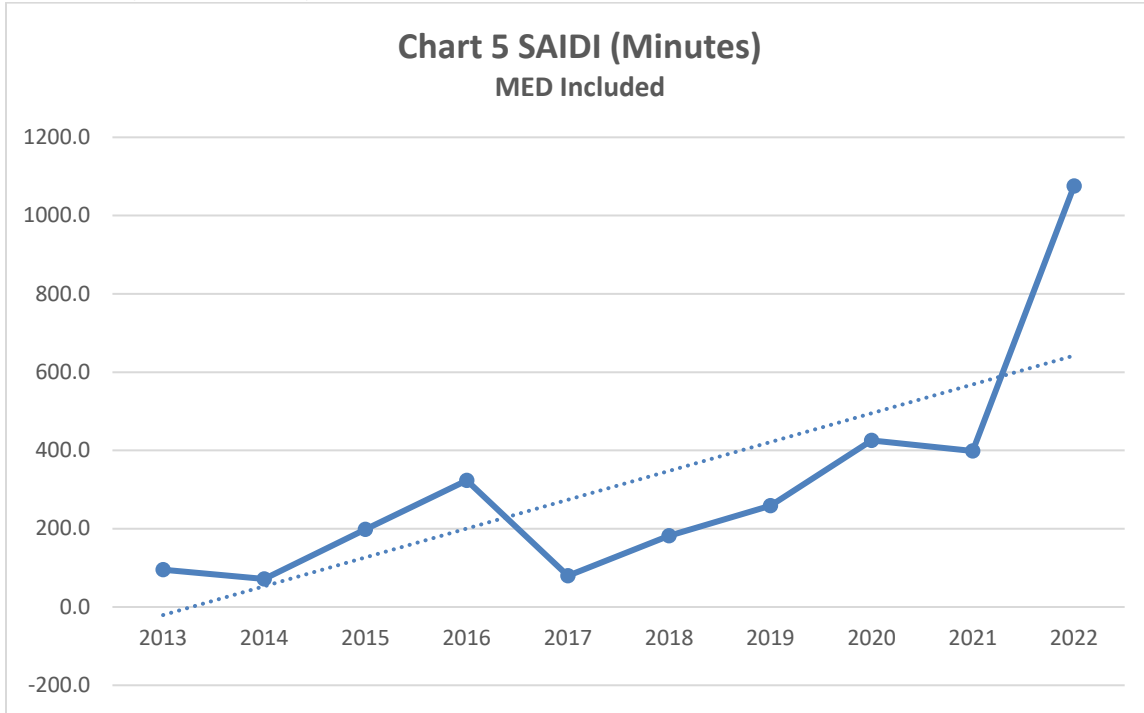
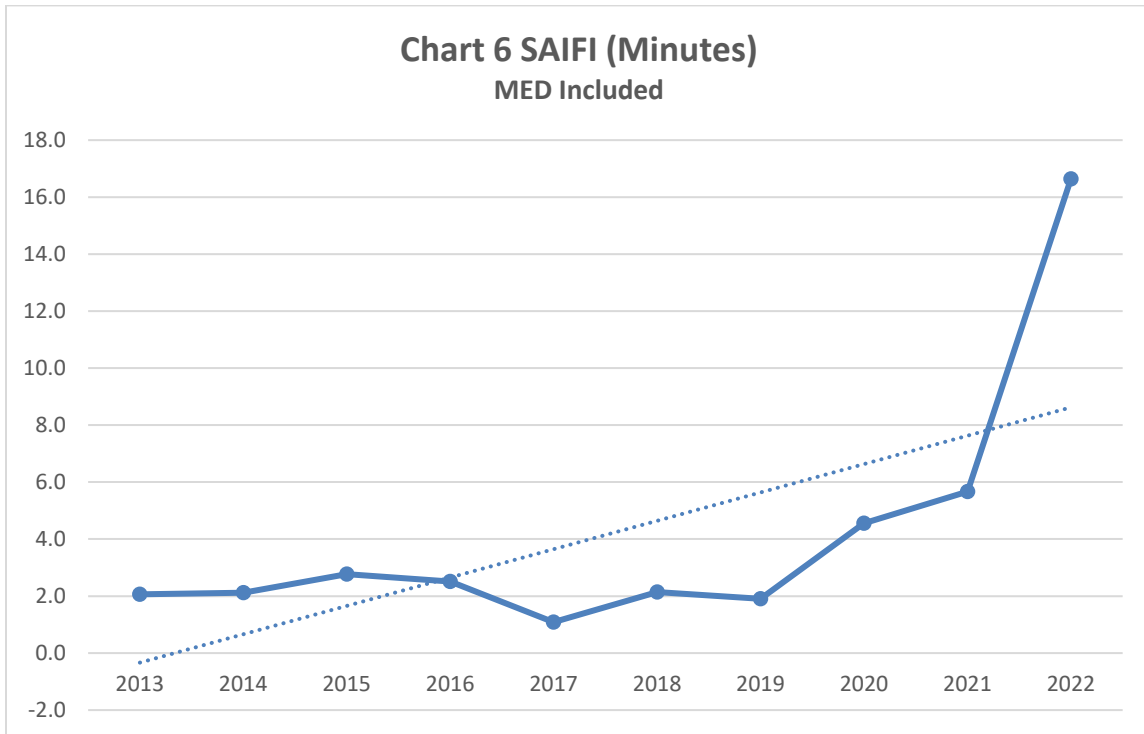
Charts 5 through 8 provide line graphs of SAIDI, SAIFI, MAIFI and CAIDI for the past 10 years with linear trend line (MED Included).

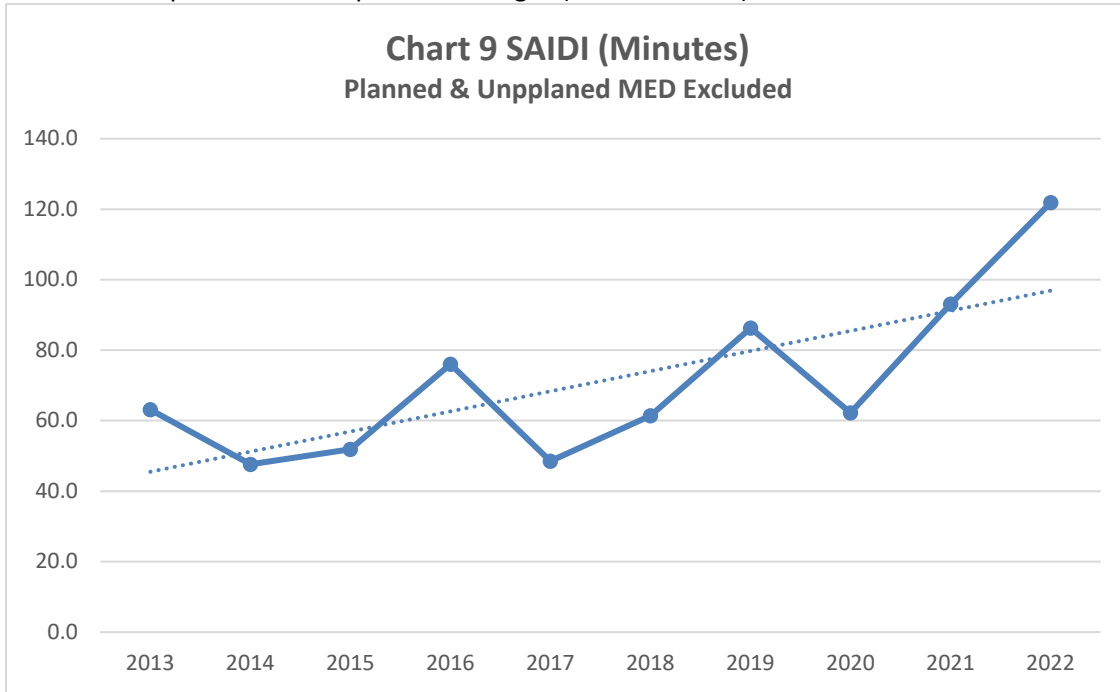
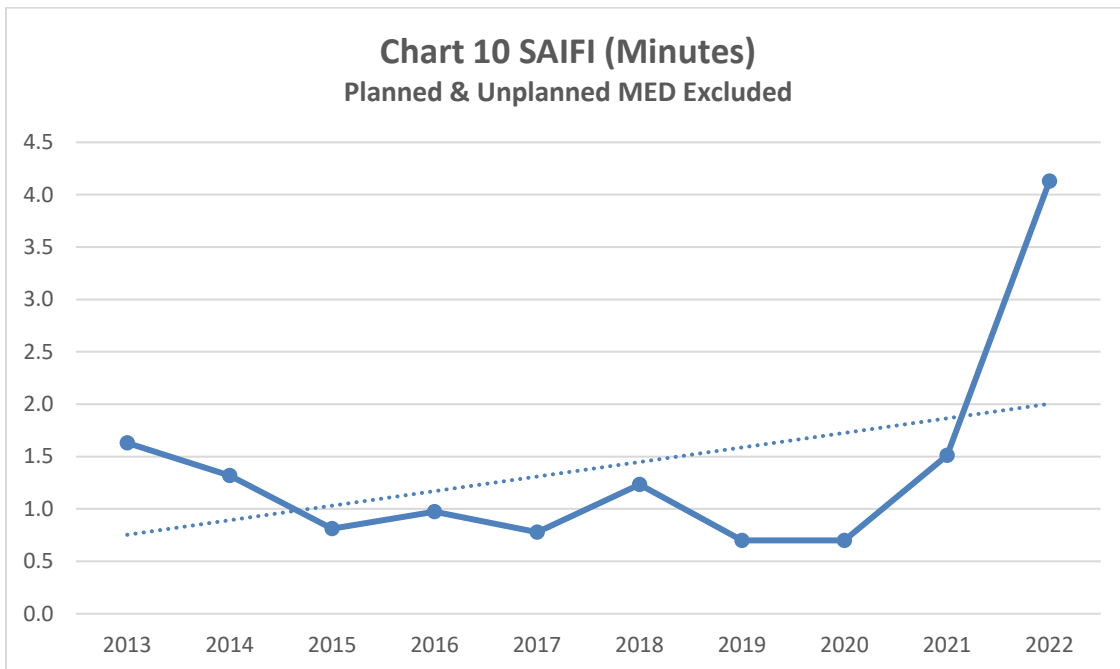
Charts 9 through 12 provide line graphs of SAIDI, SAIFI, MAIFI and CAIDI for the past 10 years with linear trend line for planned and unplanned outages (MED Excluded).

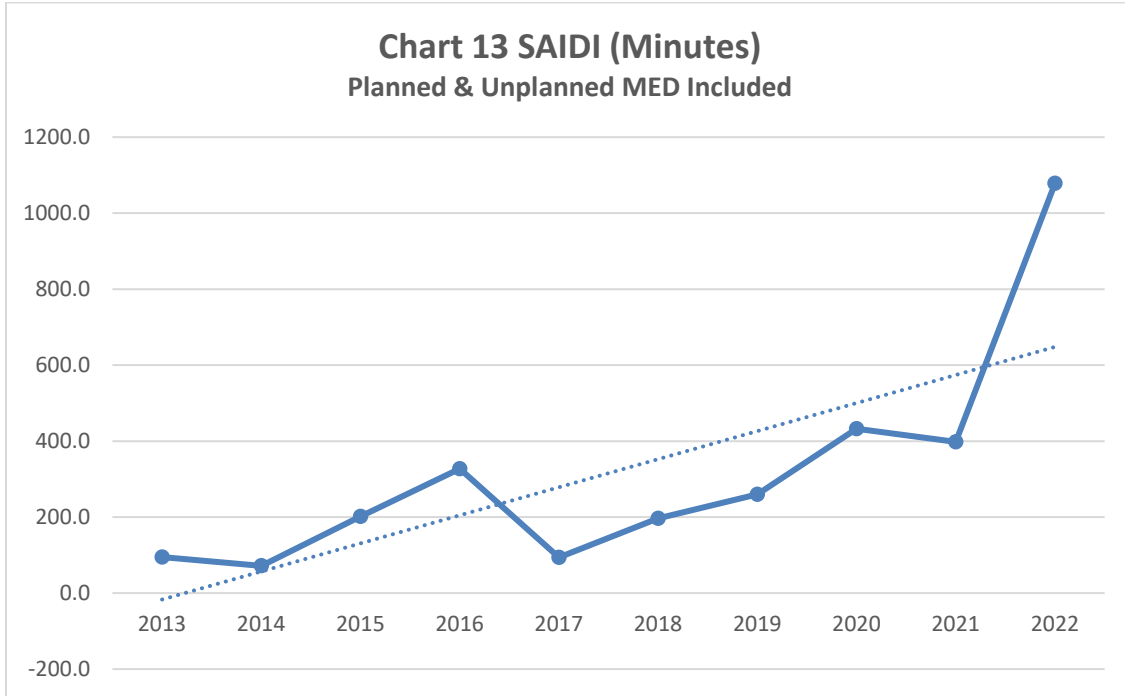
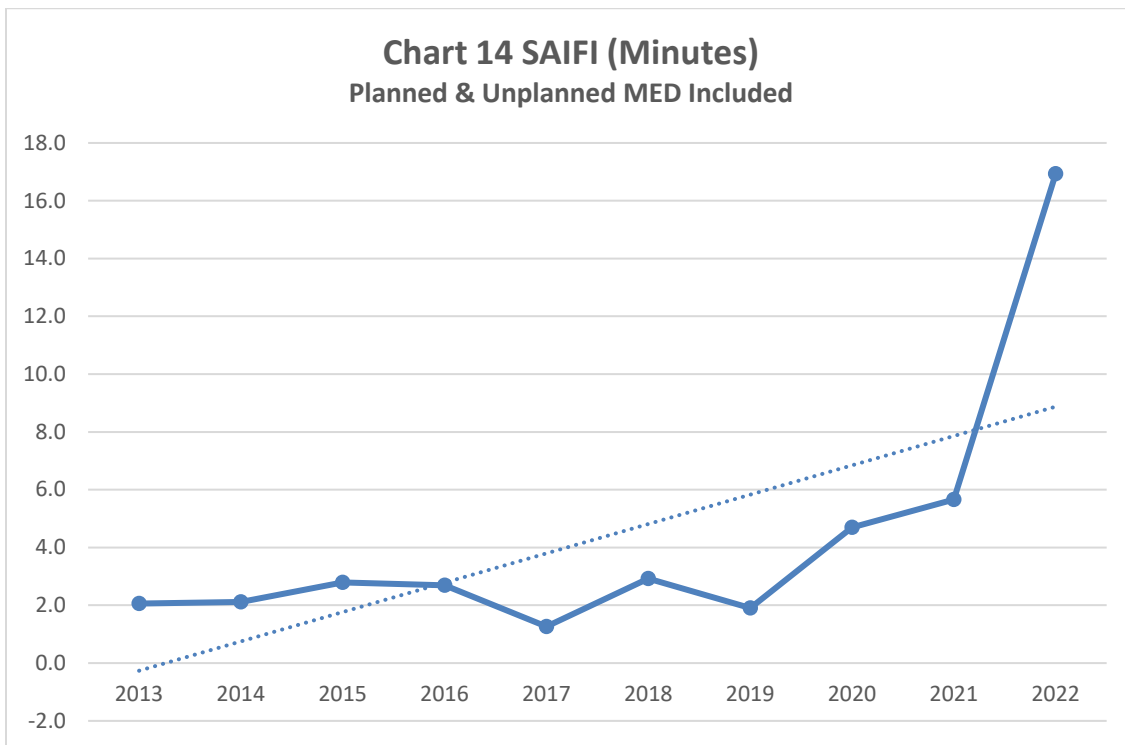
Charts 13 through 16 provide line graphs of SAIDI, SAIFI, MAIFI and CAIDI for the past 10 years with linear trend line for planned and unplanned outages (MED Included).
